Seismic performance validation for RC building structures damaged by Durres earthquake, Mw6.4, 26 November 2019, Albania

Abstract

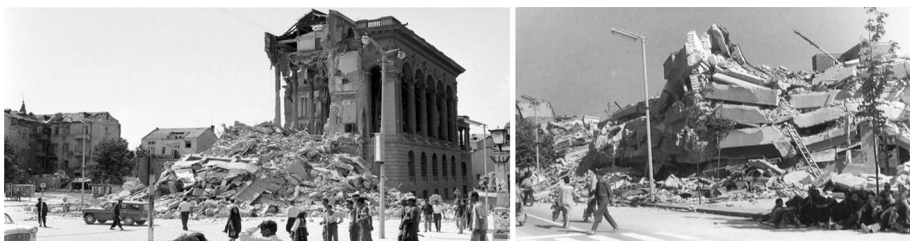
Fig. 1 (left) The Officers' Hall building, following the earthquake. Perhaps the most beautiful building that Skopje lost in the wake of the earthquake, (right) "Sloboda" square in ruins

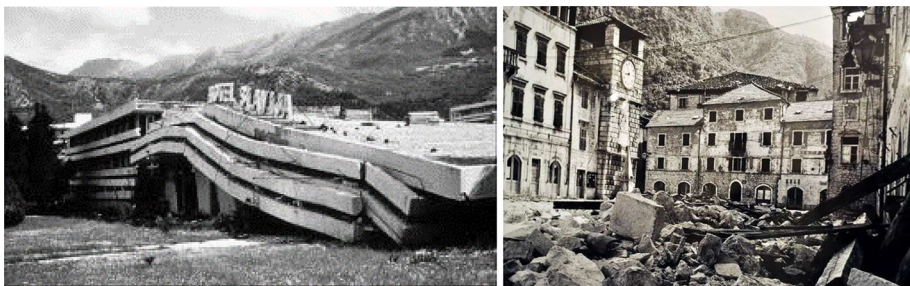
higher than that of buildings constructed in diluvial-alluvial site soil conditions. It was also found that the observed vulnerability of masonry structures was generally increased with the increase of the number of storeys, but it was merely independent of the number of storeys in the case of RC classes of buildings (Petrovski et al. 1982). Damages caused by the 1979 earthquake with magnitude 7.0 in Montenegro are shown in Fig. 2.

Fig. 2 Damage caused by the 1979 earthquake of magnitude 7.0 in Montenegro. (left) “Slavia” Hotel (Photo, by courtesy of Prof. Branislav Glavatovic, MSO, Montenegro.) (right) Old town of Kotor

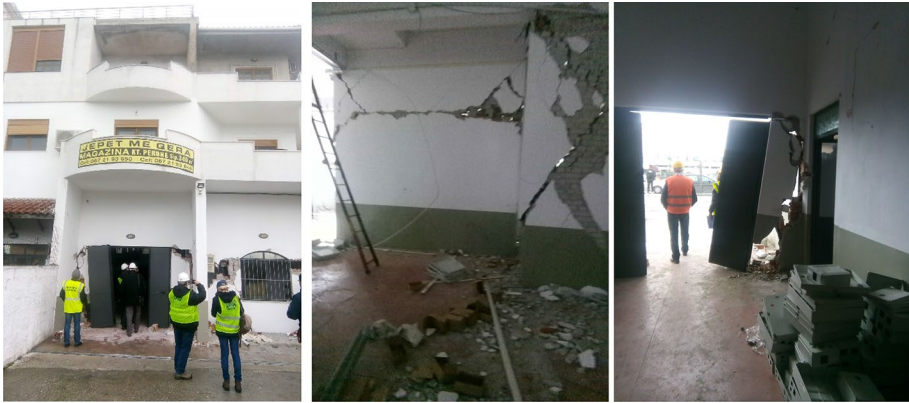
3.3.1.5 Summary of results on low-rise buildings Almost all analyzed structures with different structural system show potential damage to the first level, with deformations and ductilities that are considerably higher than the capacity of the structures and the acceptable ones by the regulations. During an earthquake, such deformations cause heavy structural damages up to unusable structures, or necessity for their tearing down or repair and strengthening at huge costs. The knowledge obtained from these analyses of the performance of such structures completely corresponds with the damages found during the visual inspection of modern RC buildings in Durres.

Fig. 16 Low-rise buildings with heavy structural damage to the first level after the Durres earthquake

These structures are usually designed by mediocre design engineers, while their construction most frequently lacks sufficient engineering control. This was observed in the case of the 3-storey structure for commercial/residential use shown in Fig. 16.

The structure manifested heavy structural damage only due to inappropriate construction, or more precisely, due to low quality of concrete and embedded stirrups with an improper diameter as well as improper overlapping distance and length (Fig. 17). This contributed to a regular frame structure to be built so as to suffer such damage. In this case, a question is posed as to the necessity for optimization of the structural systems in designing for an earthquake record defined for a corresponding location.

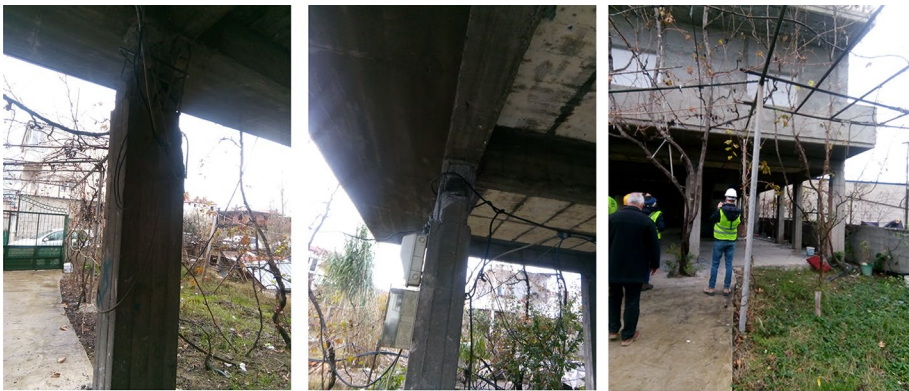
Fig. 17 Damaged columns at the ground floor of a low-rise building after the Durres earthquake

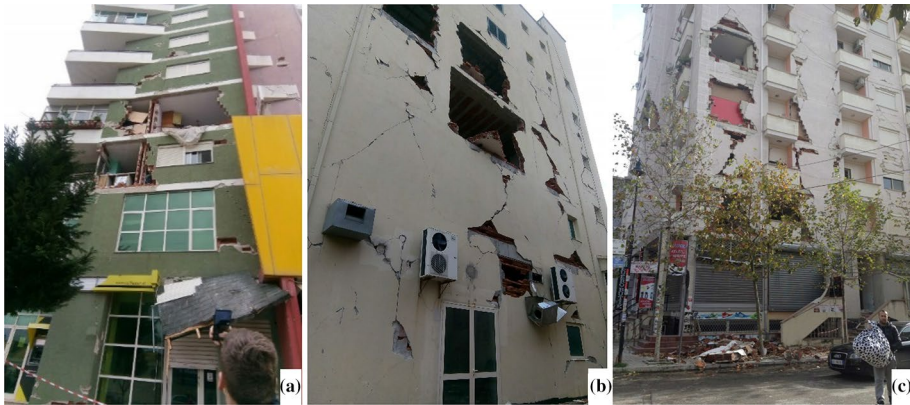
These results completely correspond to the manifested damages to modern mid-rise RC structures in Durres (Fig. 20), the difference being that these suffered considerably larger deformations and damages due to inconsistent application of recent knowledge in design, construction and quality control of earthquake resistant structures. Structural flaws in design and construction as well as inappropriate quality of built-in materials were also observed (Sheshov et al. 2021).

Fig. 20 Mid-rise building damaged after Durres in Albania, earthquake 2019. **a** and **b** (Sheshov et al. 2021); **c** (<https://www.caritas.eu/earthquakes-in-albania>)

The knowledge gained from the performed analysis of the behavior of the analyzed structures fits into the manifested damage to the modern RC structures in Durres, the difference being that these structures suffered considerably larger deformations and damages due to the use of flat-slab systems (Fig. 20).

The repair and strengthening of these structures and their retrofiting requires a specific approach to the technical solution, a highly qualified labor force, materials and control, which on the other hand, is very much time consuming and costs too much. In the meantime, these structures cannot be used.
