Reconnaissance analysis on buildings damaged during Durres earthquake Mw6.4, 26 November 2019, Albania: effects to non-structural elements

V. Sheshov¹ · R. Apostolska¹ · Z. Bozinovski¹ · M. Vitanova¹

Keywords Durres earthquake · Rapid visual assessment · Structural damage · Repair and strengthening

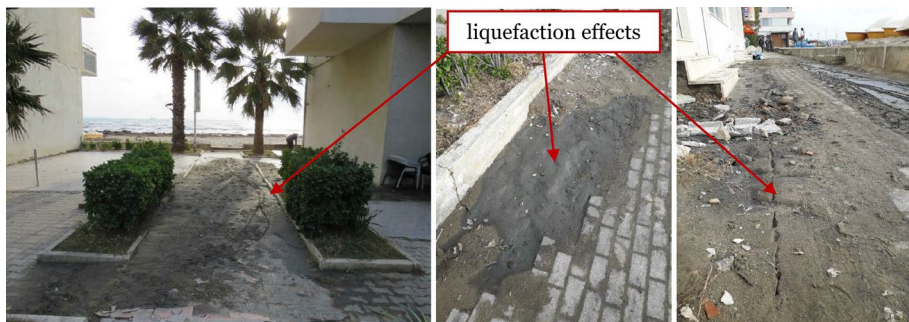
Figure 6 shows the manifestation of liquefaction effects where the sand blows and eruption of artesian water have accompanied the shaking due to the earthquake. The manifestation is limited to sandy boils having small to moderate effects on settlement of pavements.

Fig. 6 Manifestation of sandy boils-effects of liquefaction. (*Source*: Newsletter of Environmental, disaster and crises management strategies, Issue nr.15, Nov.2019)

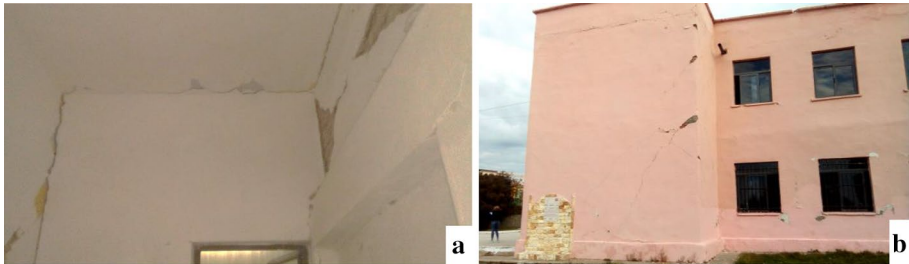
It was observed that for confined masonry structures (masonry + RC horizontal and/or vertical elements)—major damage occurred to the bearing masonry walls (separation of

walls, diagonal cracks etc.), and extensive damage to the RC beams (Fig. 14). These buildings were not able to be used immediately and must be retrofitted (Figs. 15 and 16).

Fig. 14 Damages in school building GF+1 (combined system of solid brick masonry and RC elements): **a** separation of orthogonal walls; **b** shear damage in facade wall with diagonal cracks

30% of the inspected school buildings suffered major structural damage therefore it is necessary to anticipate solutions for their repair and strengthening for the purpose of providing them with the necessary safety and stability and making them functional as soon as possible.

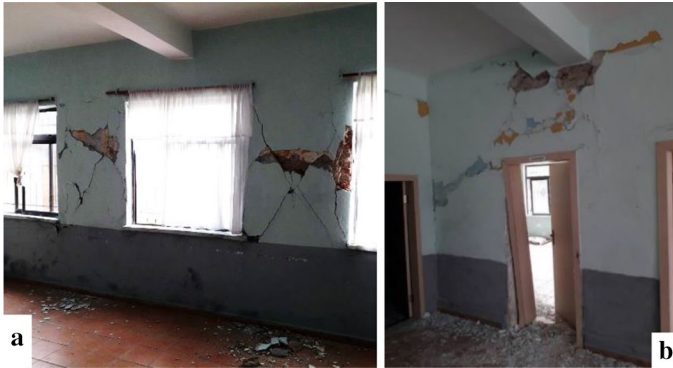
Fig. 15 Damages in school building GF+ 1 (combined system of solid brick masonry and RC elements): **a** diagonal cracks between the windows; **b** cracks in the beam supporting area

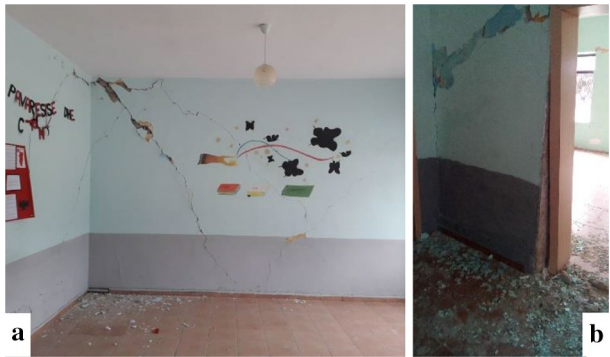
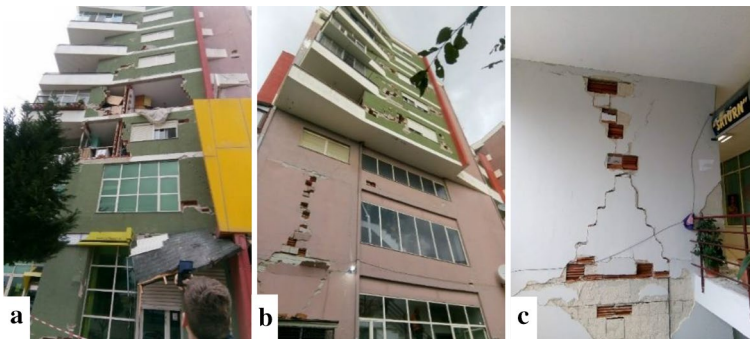
Fig. 16 Damages in school building GF+ 1 (solid brick masonry system)-diagonal cracks in brick walls. **a** facade wall; **b** infill wall

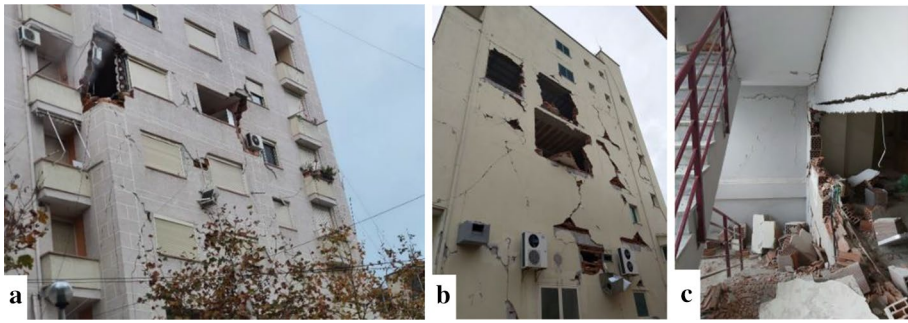
The observed nonstructural damages were expected for such structural systems and earthquake intensity (Figs. 17, 18, 19). Some of the reinforced concrete residential structures suffered slight structural damages (Figs. 20, 21, 22), but in some irregular

Fig. 17 Structures with major non-structural damage (Grade 3). **a** Failure in the front façade due to absence of belt courses; **b** damage of the rear façade in all levels; **c** shear damage emphasized with the diagonal cracks in infill wall on first floor

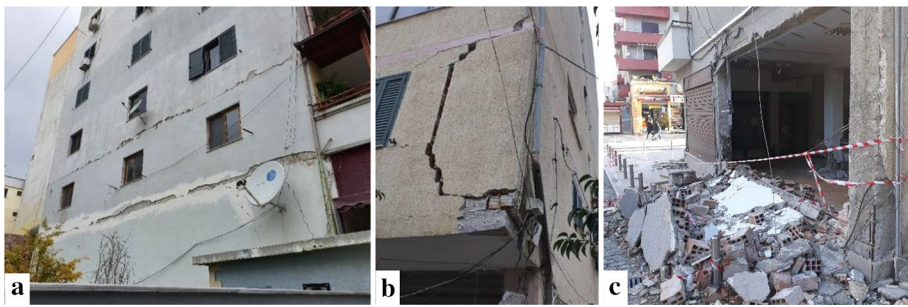
Fig. 18 Residential buildings in Durres (Grade 3). **a** Slight diagonal cracks and failure in the external facade; **b** Severe diagonal cracks and partial failure in the external facade wall; **c** failure in infill walls

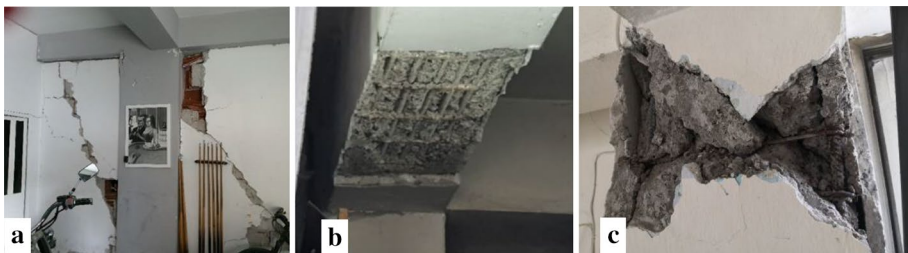
Fig. 19 Residential RC building with non-structural damage to the external facade (Grade 3). **a** horizontal cracks in facade; **b** cracks in cantilever part; **c** facade failure

were observed. In few structures, extensive damage to the facade walls resting on cantilevers was noticed (Figs. 19b, 20c).

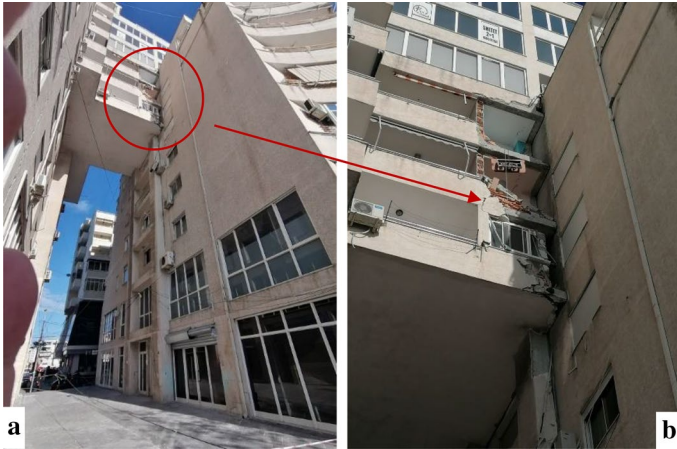
Fig. 21 Damaged bridge between two buildings located on the higher level (Grade 4). Warm connection of bridge between two buildings with undefined dynamic response

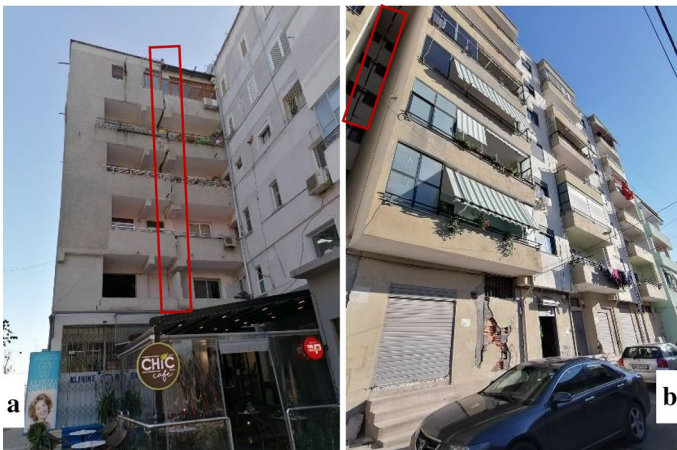
Fig. 22 Collision between two adjacent buildings (Grade 4). Expansion joint with small width

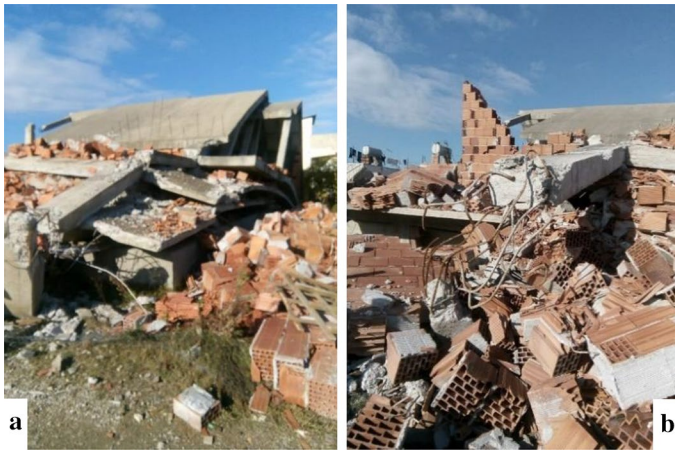
Fig. 23 Residential structures in the phase of construction that collapsed under the effect of the earthquake (Grade 5). Flat slab system where tiles and stirrups are with small diameter and stirrups located in long distance

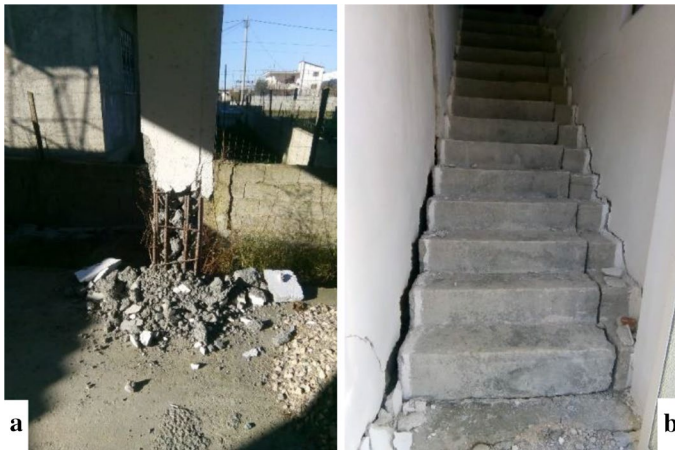
Fig. 24 Individual house GF+1 with major structural and non-structural damage due to lower quality of concrete, unsafe for habitation (Grade 5). **a** Plastic hinge in lower part of column; **b** separation of the stair structure

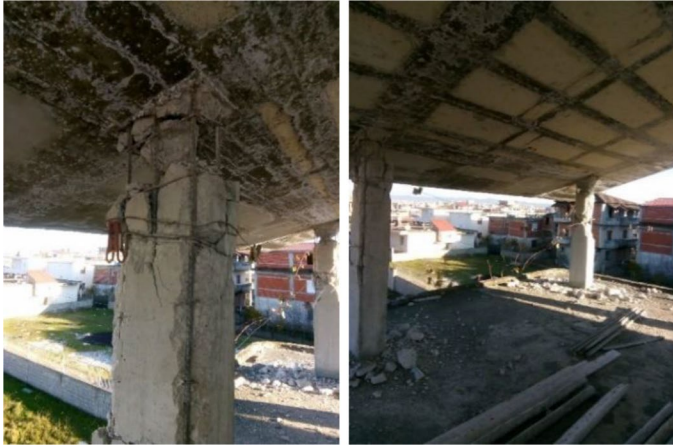
Fig. 25 Individual house GF+2 with plastic hinges in upper part of columns due to low quality concrete and stirrups with small diameter

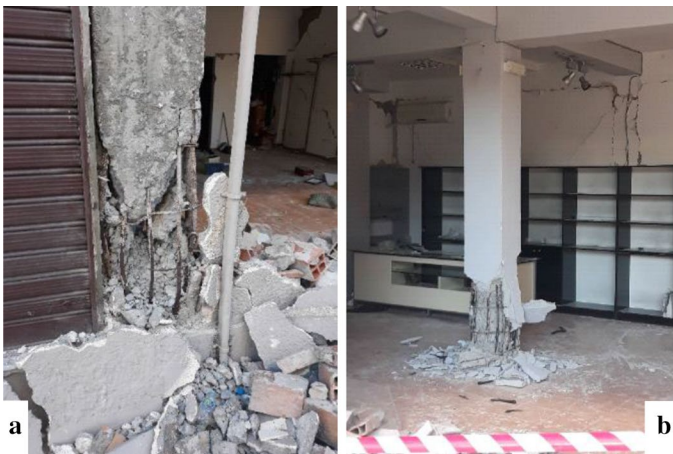
Fig. 26 Individual house GF+1. **a** Plastic hinges in lower part of facade column and failed facade wall **b** plastic hinge in middle column and separation of structural with non-structural elements
