Experiences from the application of remedial measures in hydrotechnical tunnel on Saska River – M. Kamenica

ZAFIROVSKI Zlatko¹, JOVANOVSKI Milorad², SUSINOV Bojan³, ABAZI Sead⁴, GACEVSKI Vasko⁵

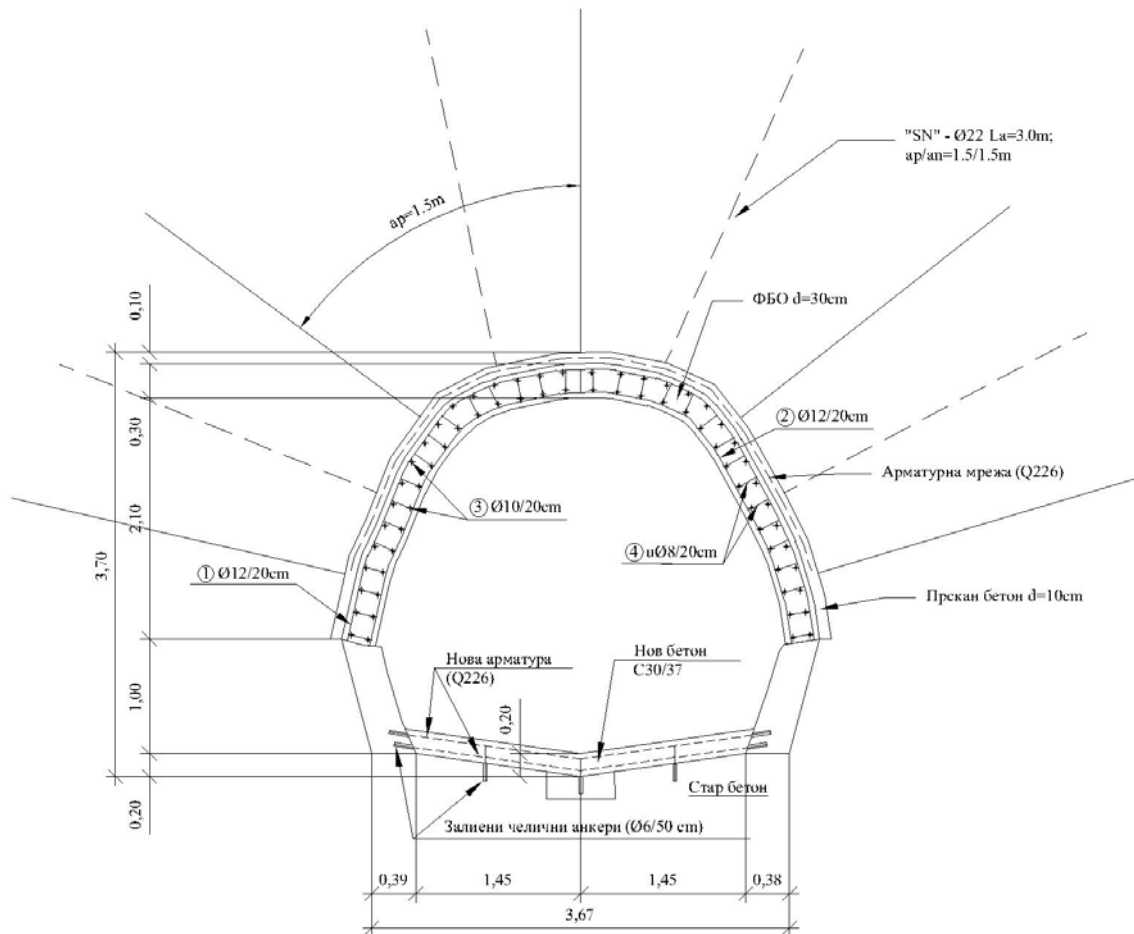
Figure 4. Tunnel cross section with primary and secondary support

A segment of the tunnel has only invert and pillars with no primary or secondary support in the upper part. For this segment multiple variant solutions were considered:

- Solution 1: Primary support from reinforced shotcrete ($d=20$ cm) and rock bolts with length of 3 m placed at 1,5 m;
- Solution 2: Primary and secondary support (reinforced concrete $d=30$ cm);
- Solution 3: Rehabilitation of the invert with anchors, new reinforcement and new layer of concrete.

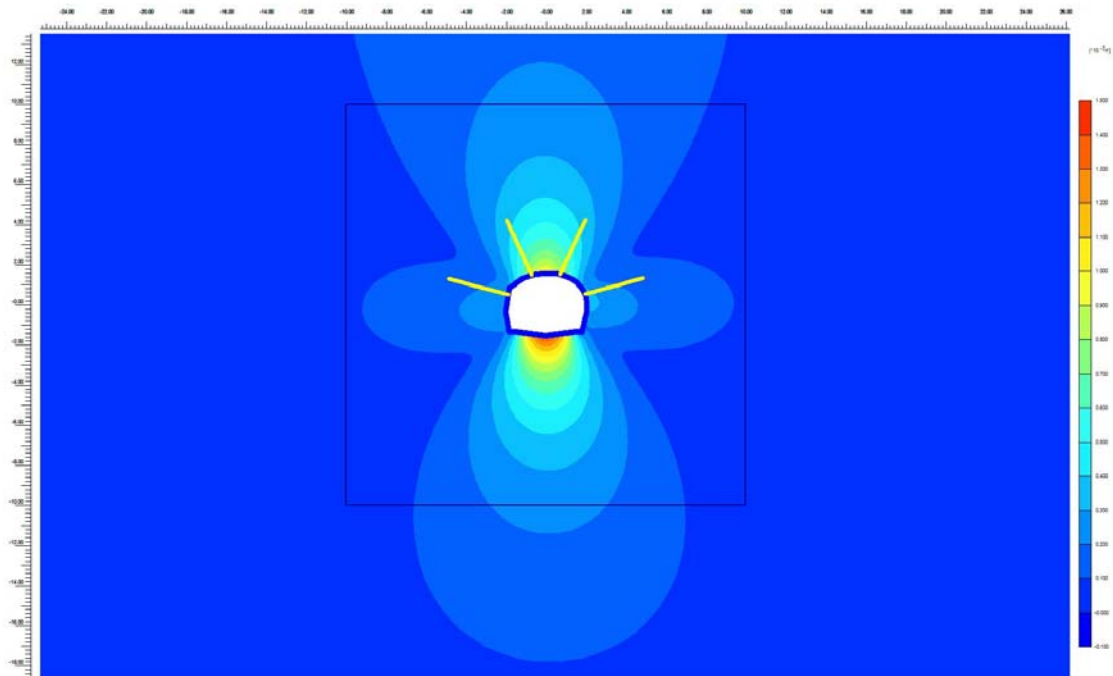
Figure 5. Deformations of the local environment and the lining

The analysis was made for multiple variant solutions covering several stages:

- Solution 1: Analysis of the tunnel with the invert and pillars from reinforced concrete (for stability control);
- Solution 2: Analysis of the tunnel with the invert and pillars, as well as primary support from reinforced shotcrete and rock bolts with length of 3 m;
- Solution 3: Analysis of the tunnel with primary and secondary support ($d=30$ cm);
- Solution 4: Analysis of the tunnel with primary and secondary support, without the invert.
