TWENTY-SEVENTH INTERNATIONAL CONGRESS ON LARGE DAMS

CONTRIBUTION ON RESTORATION OD TAILINGS DAMS DAMAGED AT INITIAL PERIOD OF CONSTRUCTION (*)

2. TAILINGS DAM SASA 4 – BASIC PARAMETERS

3. DAMAGING OF THE TAILINGS DAM SASA NO. 4 IN INITIAL PERIOD OF CONSTRUCTION ON 14.9.2020

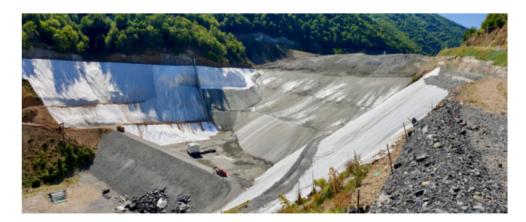
Fig. 2
Tailings dam and waste lagoon Sasa 4, February, 2020
Barrage de Tailing et lagune de déchets Sasa 4, février 2020.

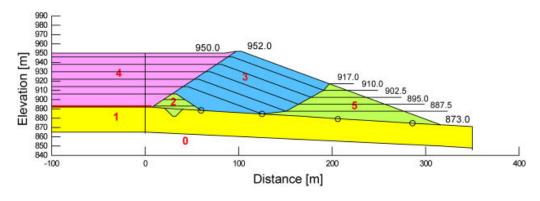
Fig. 3

Representative cross section of tailings dam no. 4, according to as built state, model with geomembrane in the riverbed.

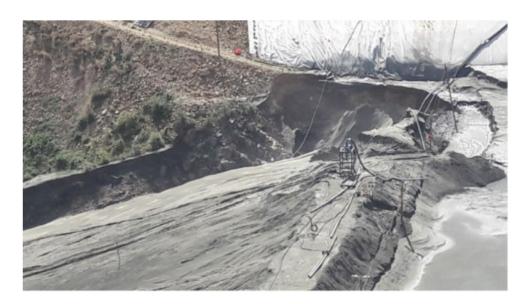
Fig. 4
Damage in the right bank of the tailings dam, state on 14.9.2020
Dommages en rive droite du barrage à résidus, état au 14.9.2020.

We are on opinion that initial leakage of water in zone of the dam crest in nearby of the right bank of valley is case of impermissible seepage. It cannot be described by established models for stationery and non-stationery seepage, based on principles of mechanics, but it can be explained by engineering logic. The impermissible seepage consists of paths of concentrated seepage that in case of progressive type can endanger stability of some parts or of the full embankment structure. It is caused by incidental occurrence of loose porous medium exposed at active action of the flow, due to design or construction errors or due to unfavorable natural ambient.

In this case, the occurrence of impermissible seepage is caused by superposition by number if influences, that according to the contribution can be divided in primary (significant) and secondary (ancillary). Primary for occurrence of the impermissible seepage are:

- (1) Unfavorable hydraulic contact of the tailings sand (from the dam shell) with coefficient of permeability $k=2\times 10^{-6}\,\text{m/s}$ and geomembrane with coefficient of permeability $k=10^{-12}\,\text{m/s}$. It is a case of hydraulic contact of two materials that extremely differs by its permeability. This led to fully redirecting of the flow lines towards the les permeable material tailings sand and it created initial contact seepage.
- (2) Insufficient length of the beach from tailings mud, upstream of the upstream edge of the dam crest that conditioned close vicinity of the water from the waste lagoon to the dam sand. Such vicinity does not result with significant loss of water head of the seepage flow before the contact with the sand dam apropos it had maximal head along the exactly along the upstream slope of the sand dam.

- (3) Great natural slope in the right bank of the valley, that conditioned "hanging" of the soft tailings material on the stiff rock foundation, that is manifested by unfavorable transfer of stresses and occurrence of loose (insufficiently compacted) earth, through which is eased hydraulic breach if exposed to seepage flow.

- (3) Unfavorable natural configuration of the terrain by widening of the valley downstream of the sand dam and eased displacement in downstream direction at action of the hydrostatic pressure that conditioned the tailings sand not to be pressured in the contact with the rock in the bank but to be loosened, that additionally worsens the seepage through the dam.

The first stage of the damaging restoration of the tailings dam Sasa no. 4 regards the dam stability. Such stage is urgent and should be used current favorable weather conditions (without rainfalls) and the taken material in the right bank of the dam (tailings sand) to be replaced by appropriate local material, for which we emphasize following recommendations:

- 906.0 masl (or till elevation according the as built drawing). The material should be sufficiently compacted by available machinery of mine Sasa.
- (3) During the spreading and compaction in layers of the mine rock, special care should be taken for employees safety and firstly the steep surfaces of the tailings sand (that are almost vertical), created by the accident, should be soften. Such vertical surfaces we believe that are in state of limit equilibrium and any moment (by small variation of the humidity) is possible occurrence of local instability and sliding on the steep slope.

- (7) At contact of the embankment from tailings sand and the right bank the three-layer geosynthetic lining to be removed (at least 2 m upstream from the contact of the sand dam with the terrain, and in zone of crest support (width of 5 m) the local material should be removed, at depth of 0.5 m or at level of rock foundation. Namely, such material was placed in order the unevenness to be leveled for installation of the geosynthetic lining. Such material is extremely permeable and it must be removed in trench by approximate dimensions of 5 m (in width as the dam crest width) and 0.5 m (depth in permeable local material or till rock foundation in the bank), at the contact of the dam crest with the terrain.

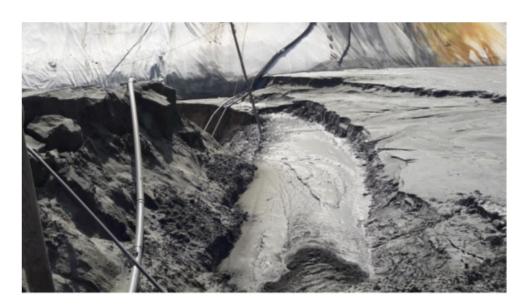
Fig. 5

Opening at dam crest where the discharge of the stored waste water took place Ouverture à la crête du barrage où a eu lieu l'évacuation des eaux usées stockées.

to the original slope with inclination 1:2.7) of approximately 5.0 m. It is estimated that it was discharged approximately 3,000 m3 tailings sand from the dam body.

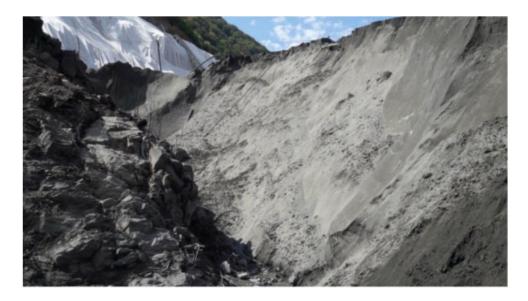
The mixture of water from the waste lagoon that leaked uncontrollably through the breach point in the upper zone in the right bank of the tailings dam and tailings sand of the downstream part of the dam has propagated downstream of the tailings

Fig. 6
Tailings sand that was taken away from the downstream body of the dam
Sable de résidus qui a été enlevé du corps en aval du barrage.

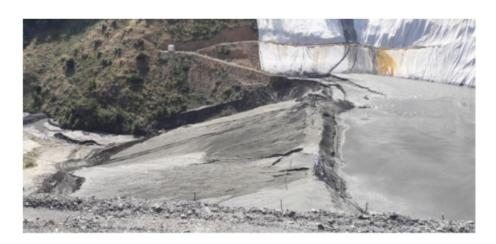
Fig. 7
Stopped erosion of the slope of tailings dam Sasa no. 4 on 14.9.2020
Arrêt de l'érosion de la pente du barrage de résidus Sasa no. 4 le 14.9.2020.

dam toe. Such mixture of water from the technological process (deposited in the lake) of approximately 8,000 m3, along with pure water downstream of the terminal structure of the diversion tunnel, has transported, spreaded and deposited on large section of Kamenicka river. As soon as the water level has lowered and equaled with elevation of sufficient length of the beach from tailings mud, directly upstream from the dam crest, the process of further impermissible seepage through the tailings dam and surface flow along the downstream zone of the dam has stopped, that enabled also and the dam erosion to be stopped (fig. 7).
