COMMISSION INTERNATIONALE
DES GRANDES BARRAGES

VINGT SIXIÈME CONGRÈS
DES GRANDS BARRAGES
Vienne, Juillet 2018

CRACKS AT MATKA ARCH DAM – A CASE STUDY*

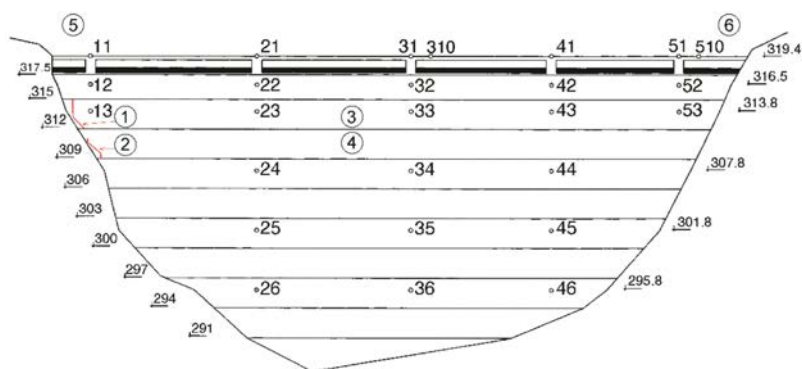
Fig. 2

part of the dam were visually recorded, located in the immediate vicinity of the right abutment, through which a small amount of water licked. The first crack was on the arch IX near the measuring point 13, and the second one on the arch VIII, under the measuring point 13, Fig. 2. On July 26, 2012, the author and the first coauthor of this paper performed a visual inspection of the dam, with special attention to the zone of the cracks, took photographs and gained certain data from the responsible person of the dam. In Fig. 3, the cracks at the ends of the arches IX and VIII near the right abutment can be seen. During the inspection of the dam, the reservoir was almost full, that is, the upper water level was at elevation 315.83 m.a.s.l. On July 31, 2012, with appropriate equipment, we came to the cracks zone on the downstream dam side making a direct inspection of the cracks. Thus, we came to the following important findings:

Point for measurement of the displacements on the downstream dam face
Point de mesure des déplacements sur la face du barrage en aval

1	Crack 1	1	<i>Fissure 1</i>
2	Crack 2	2	<i>Fissure 2</i>
3	Arch IX	3	<i>Arc IX</i>
4	Arch VIII	4	<i>Arc VIII</i>
5	Right side	5	<i>Côté droit</i>
6	Left side	6	<i>Côté gauche</i>

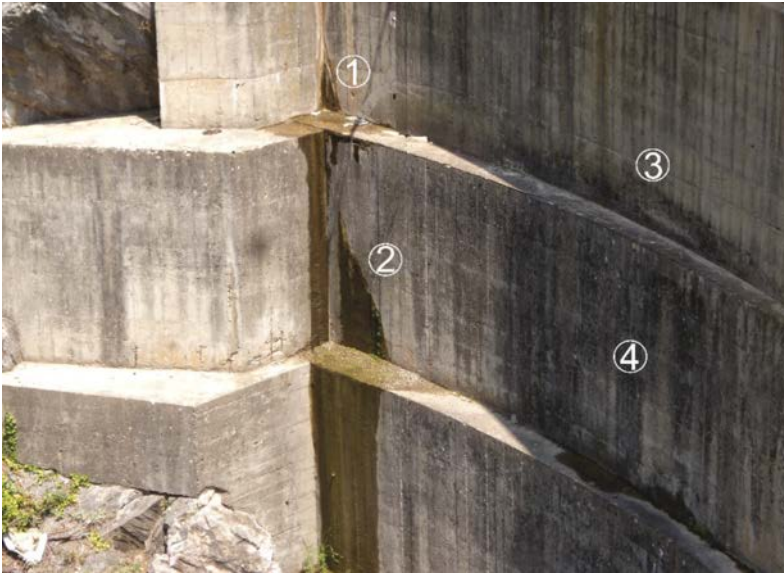
Fig. 3
Location of the cracks
Emplacement des fissures

1	Crack 1	1	<i>Fissure 1</i>
2	Crack 2	2	<i>Fissure 2</i>
3	Arch IX	3	<i>Arc IX</i>
4	Arch VIII	4	<i>Arc VIII</i>

Crack 1 was extended along the entire height of the arch IX, from the elevation 315.00 m.a.s.l. (upper edge of the arch) to the elevation 312.00 m.a.s.l. (lower edge of the arch). The crack first was extended vertically just near the contact between the arch and the foundation block, from the elevation 315 to the elevation 313 m.a.s.l, to which it became inclined to the end at the lower arch edge. The vertical part of this 190 cm-long crack was dominantly dry, while the sloping section, 117 cm long, was wet or with little leakage. On the vertical part, the width of the crack was considerably less than 1.0 mm, while on the sloping, moist part, it was estimated that in several places it reaches 1.0 mm.

- The start point of Crack 2 was 90 cm below the upper edge of the arch VIII, and the first 20 cm were almost vertical, and then the crack was inclined in a

length of 140 cm. After that there was a nearly vertical part, 56 cm long. At the upper end, at an elevation of 311.10 m.a.s.l., the crack was of low width, but going down its width increased continuously up to 2 mm. Water penetration was visible throughout its whole length.

- At the time of the inspection the surface of the concrete around the vertical part of the crack 1 was dry, but a thin layer of limescale was a sign that occasionally there was a penetration of water and that the crack is of an older date. The surrounding area of the inclined crack part was wet, and a slight water leakage was evident. A layer of deposited limescale around the sloping part of the crack was noted, up to 3 mm thick, suggesting that the leakage was continuous and that the crack was from the older date.

- The surface around the crack 2 was wet over the entire length of 216 cm, and a clear water leakage was visible. Around the lower, finished vertical part of the crack, there was a surface with a green developed moss. Deposits of limescale along the crack reached a thickness of 5 mm, and even more. All of this suggested that the leakage was continuous and that the crack is of an older date.

It was concluded the restoration of the cracks to be performed by grouting. The trial injection helped to prepare a recipe for grouting of cracks, with strong technical characteristics of the adopted materials for preventing the filtration of water through them and constructive monolithization of the concrete. Within the preparation of the basic design, the manufacturer of the grouting materials (TPH Germany) confirmed the accepted grouting mix and certificated the materials for the preparation of the grouting mass. On the basis of the basic project prepared, the grouting of the cracks was completed within ten days in July 2016, with application of the prescribed safety conditions. With the regular technical surveillance of the dam in 2016 it was concluded that in the zone of the cracks there is no moistening of the concrete. With the rehabilitation project it was recommended that if it is eventually necessary the water level in the reservoir to be significantly reduced, such operation to be done in autumn or spring, when the air and water temperatures are approximately equal.

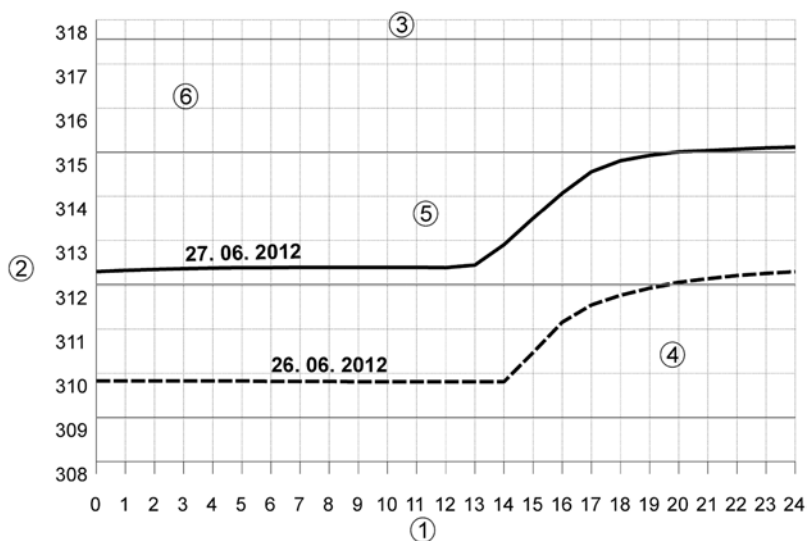
Fig. 4

Graphical presentation of the Matka reservoir filling on June 26 and 27, 2012
 Présentation graphique du remplissage du réservoir Matka les 26 et 27 juin 2012

Figure 4 gives a graphical representation of the reservoir Matka filling, carried out on June 26 and June 27, 2012. The drawing also shows the edges of the top three arches of the dam – VIII, IX and X. From the graphs it is clearly visible that on June 26, between 14 h and 19 h, the water submerged the upper 2/3 of the arc VIII, previously exposed to warm air. The next day, with the greatest intensity between 13 and 17 o'clock, was also completely submerged the upper arch IX. In the next three days, from June 28 to June 30, the upper water level was increased to 315.69 m.a.s.l., the temperature of the air remained high, while the drop in the water temperature from 17 C° to 11-13 C° was noticeable, due to the fact that the reservoir Matka was filled with cold water supplied from the upper hydroelectric power plant in the frame of the hydraulic scheme Kozjak.

It is obvious that the extremely high temperatures, at which both arches were exposed, not only from the downstream, but also from the upstream side in June, especially in the period from 15 to 26 June, caused their expansion and leakage after raising the reservoir level on June 26 and 27, which made it possible to become visible. With both cracks, the arches VIII and IX, in which, like all others in the body of the Matka dam, vertical joints were not made during the construction, they formed natural joints in the zone of high tangential and tensile stresses occurring at extremely unfavorable combinations of temperature loads. Thus, the expansion of the cracks was a result of both climatic and human factors, because the reservoir was emptied, and then filled up at a high rate, under unfavorable environmental conditions.
