Second International Symposium on Risk Analysis and Safety of Complex Structures and Components (IRAS 2023)

Solutions and Procedures for Repairing a Damaged Vertical Cylindrical Tank – Depositor

Elisaveta Doncheva^a, Viktor Gochev^b, Aleksandra Krstevska^{a,*}

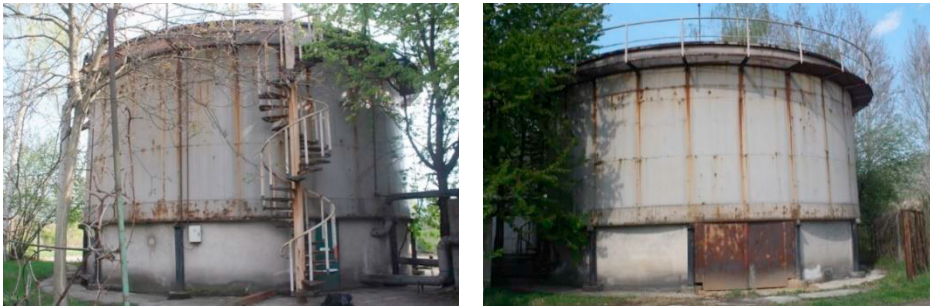
Fig. 2. The tank with a view of both sides

The paper describes and evaluates repair and rehabilitation options for a damaged vertical cylindrical tank (depositor). The vertical cylindrical tank is part of a wastewater treatment plant located in the metallurgical plant for the production of ferrosilicon. The wastewater treatment plant station is used to reduce and neutralize the carcinogen hexavalent chromium (Cr VI) into Cr-III (three valent chromium), and its components, shell, and floor are severely damaged because of the tank's long-term exploitation and poor maintenance. Fig. 2 shows a view of both sides of the tank.

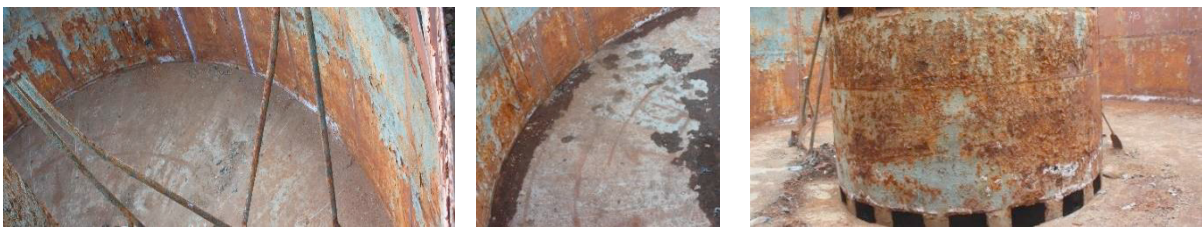
Fig. 3. Photo documentation of the current situation of the tank

At the current operation of the treatment plant, the solid components are not removed, and they are deposited from the bottom to the upper parts of the vertical tank. The tank is designed for working fluid water with a low concentration of sediment with a specific weight of $1\text{kg}/\text{dm}^3$ (Cubic Decimeters), and the condition found is 2.7 times greater, specific mass of sediment in the depositor, that is, a fluid with $2.72\text{kg}/\text{dm}^3$ (Cubic Decimeters).

Because of the excessive amount of residual sediment inside the depositor (fig.3) there is a:

1. Local leakage of the content from inside the depositor through its bottom
2. Deformations of the cylindrical casing of the depositor

The following methods are considered for the repair of the vertical cylindrical tank – depositor:

1. Repair welding at locations where the damage is present.
2. Addition of lost material by applying liquid composite metals (applying a multi-purpose machinable composite material Belzona 1111 – super metal)

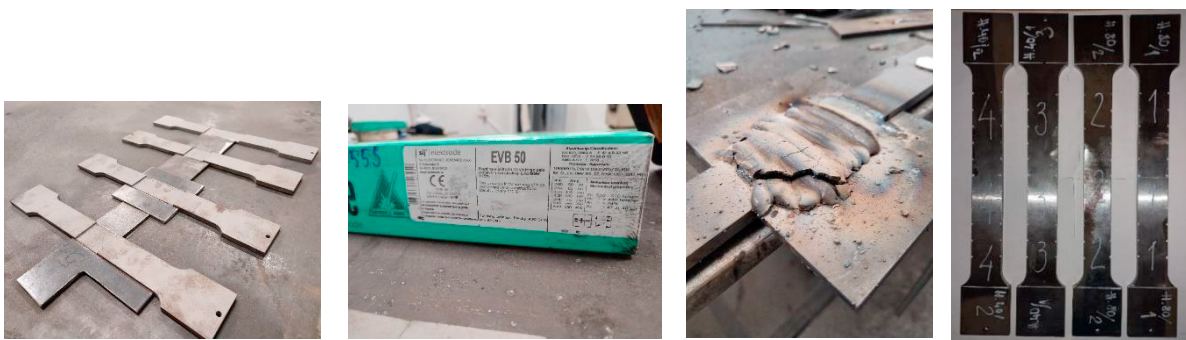
Fig.5: Preparation of samples by repair welding

The process of preparing the specimens with the repair welding technique is shown on figure 5 and on figure 6 is shown the preparation of samples by adding an additional liquid super metal. The specimens 5 and 6 presented on figure 7 a) are made without defect to only compare the results of the tensile test as standards and all marked specimens with defined defects are presented on figure 7 b).

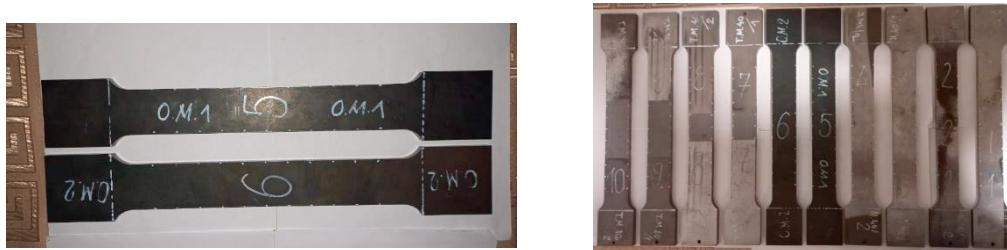
Fig.7. a) Samples from base material without defects and without repair, as standards for comparing the results of the tensile test; b) Samples for tensile testing with the previously defined number of marks depending on the dimensions of the defect and the method of its repair

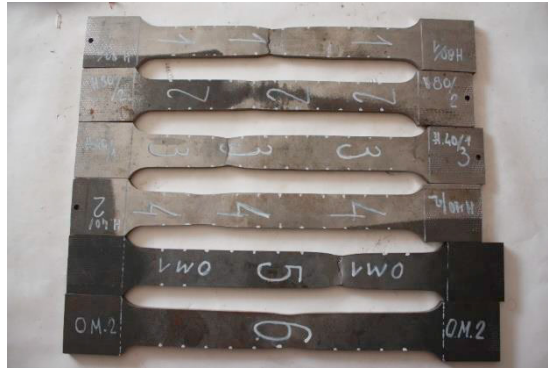
Fig.8: Repair welding

After tensile test of specimens made with repair welding, shown in Figure 8 and the performance conditions of the specimens in this figure impose the question of analysing the reasons why the samples with a larger defect length fracture in the weld zone or opposite why the sample with a smaller defect dimension fractures in the base material.

The samples with repair welding show greater deformation characteristics than those repaired with liquid metal for both the 46 mm defect case and the 92 mm defect case. The performed repaired welding of the defect with a length of 92 mm yielded in the welded metal and the performed welding of the defect with a length of 46 mm yielded in the base metal. Samples with 92 mm repair welding have smaller ultimate deformations than those with 46 mm repair welding. Tests of base material without defects and without repairs fully confirmed the strength-deformation characteristics of S360.

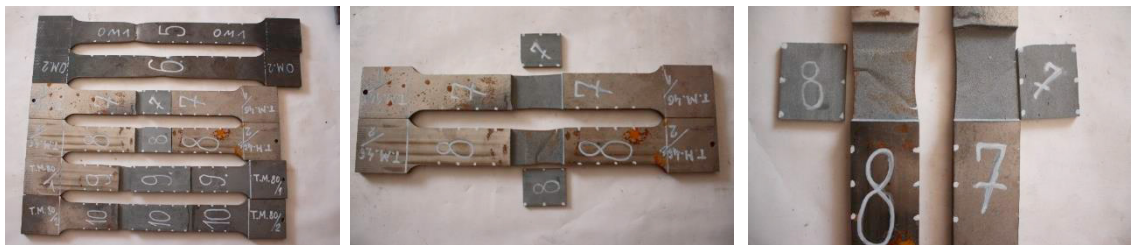
Fig.9: Repair with liquid metal

On the other hand, the binding/adhesive force of the liquid metal with the base material separated in the elastic state of deformations for the base material, shown in Fig. 9. The measured lengths of the liquid metal after the test for both test (7 and 8) specimens are 46.66 mm. The plastic deformation of the liquid metal at the time of fracture from the base metal is 1.43% and the moment of fracture of the liquid metal from the base material was accompanied by a sound. The examination after fracture of the liquid metal from the base material has no special significance, at least at this point of examination.

Repairment with liquid metals with 46 and 92 mm separated from the base metal in the elastic state of deformations. The absolute elongation of the liquid metal with a length of 46 mm is 0.66 mm, i.e. 1.4%, and the absolute elongation of the liquid metal with a length of 92 mm is 0.1 mm, i.e. 0.1%. Test samples repaired with liquid metal with 46 mm have smaller ultimate deformations than those with 92 mm. Longer lengths of repair welding and repair with liquid metal give worse deformation characteristics during tensile testing.

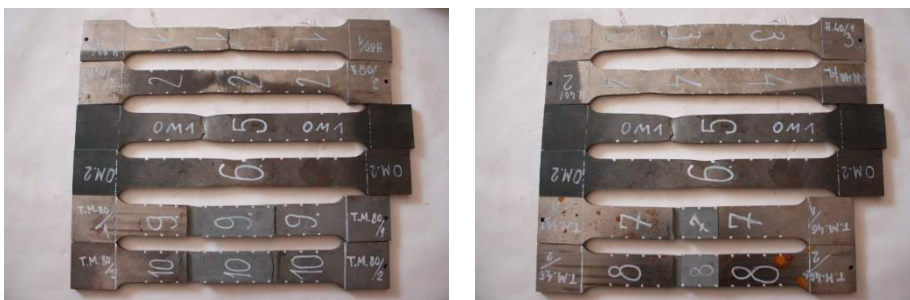
Fig.10: Test samples

On fig 10 is presented a view of test specimens with a 92mm defect repaired by welding and liquid metal compared to samples form base material, left, and the same conditions for a 46mm defect, right.

In this paper are analysed the tensile characteristics of the material with two different repair techniques as methods for repair of cylindrical vertical tank/depositor. After the experimental part is concluded that the specimens with repair welding give better deformation characteristics than the specimens with liquid metal.
