**THE 7th INTERNATIONAL CONFERENCE
"CIVIL ENGINEERING - SCIENCE AND PRACTICE"**

GNP 2020 – Kolašin, Montenegro, 10-14 March 2020

**REHABILITATION OF THE RAILWAY SECTION
„KOS-TREBEŠICA“ IN MONTENEGRO**

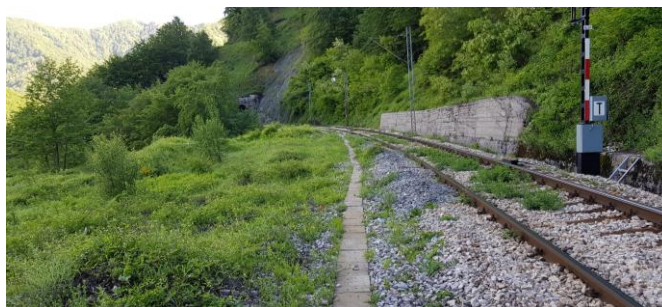
Figure 1. Section before execution of works

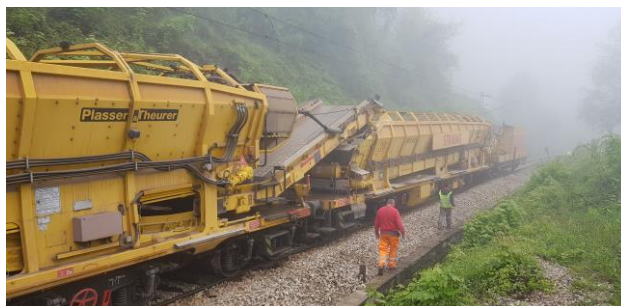
Figure 3 Mechanical ballast cleaning

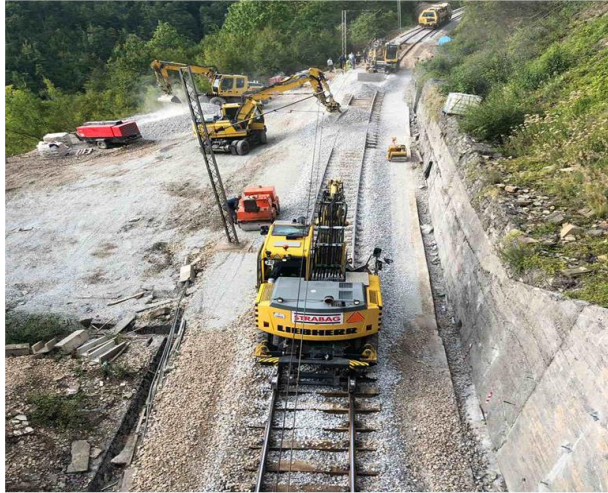
After the railway was built, a landslide (instability) was activated on the route from km 356 + 700 to km 356 + 900. At the moment of the landslide activation, the retaining wall on the left side of the railway was damaged. The landslide was partially subsided and no significant wall and terrain displacements have been recorded since then. The manifestation that has been noticed for

the past ten years is occasional consolidation of the ballast layer, which is the reason for making a high track ballast at the above-mentioned location.

Figure 4. Final works on landslide rehabilitation

The proposed rehabilitation solution comprised passive and active remedial measures for the inactive landslide. Passive remedial measures included the installation of surface drainage, deep drainage system and weep holes. Active remedial measures included:

- Strengthening of the retaining wall above the rail by installing IBO self drilling anchors. The anchors are 8m long and have a Ø32mm diameter;
- Strengthening of the substructure by installing Tensar TriAx TX 150 geogrids.

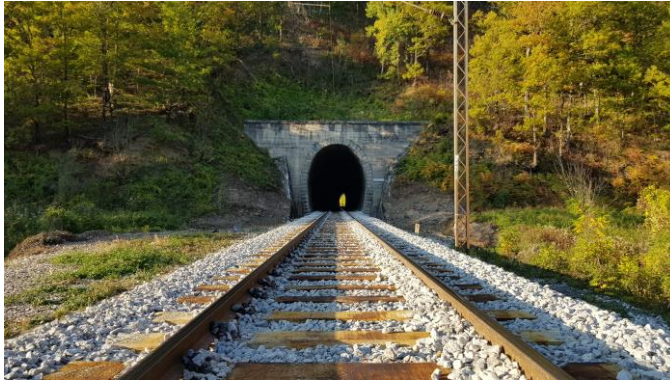
Figure 5. The route after completion of works
