Monitoring of an earth-rockfill dam and proposing revitalization measures based on interpretation of monitoring data

Bojan SUSINOV¹, Jovan PAPIC¹, Igor PESHEVSKI¹

¹Ss. Cyril and Methodius University in Skopje, Faculty of Civil Engineering Skopje, Republic of North Macedonia
Corresponding author: Bojan Susinov (susinov@gf.ukim.edu.mk)

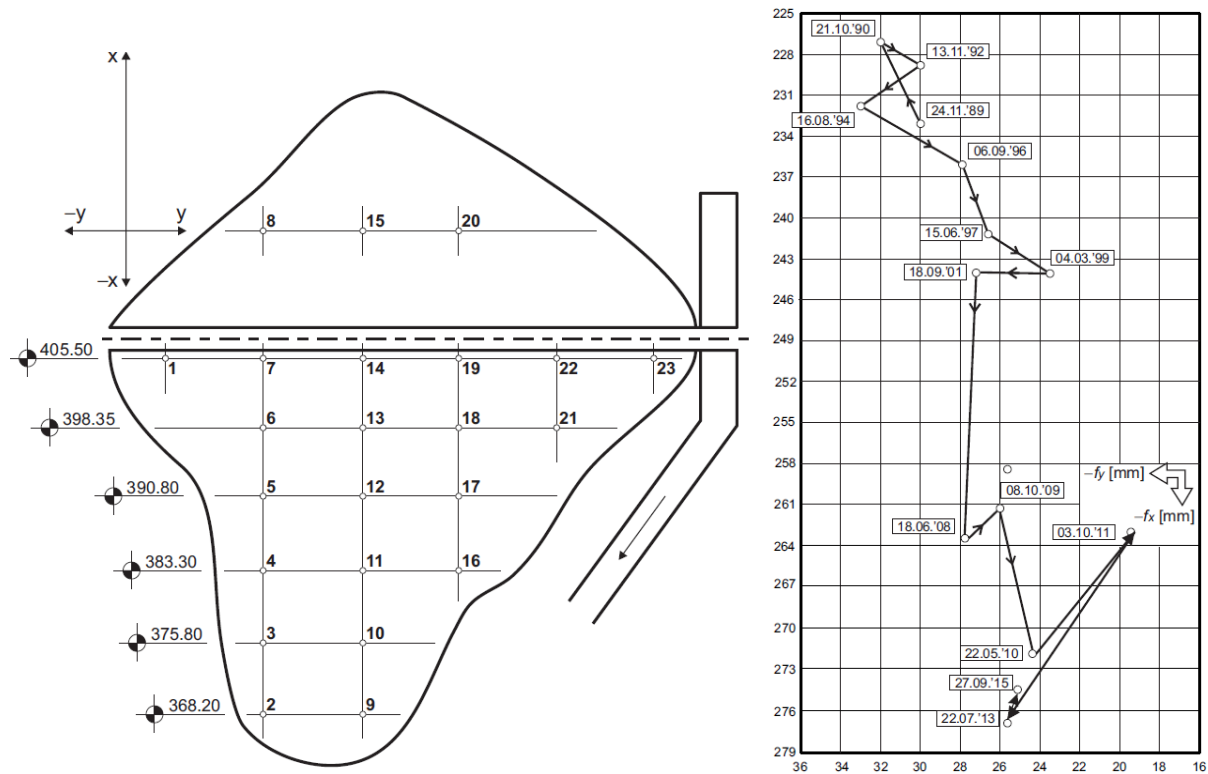
Figure 2: Marker position and the maximal horizontal displacement of the marker 19.

According to the performed measurements, the horizontal displacements of the markers on both slopes show small gradual changes directed towards the middle of the dam. The displacements along the y-axis are directed from the sides to the middle, while in the direction of the x-axis i.e. in the direction of the slopes, the maximum horizontal displacement measured so far is 274.8 mm in the mark 19.

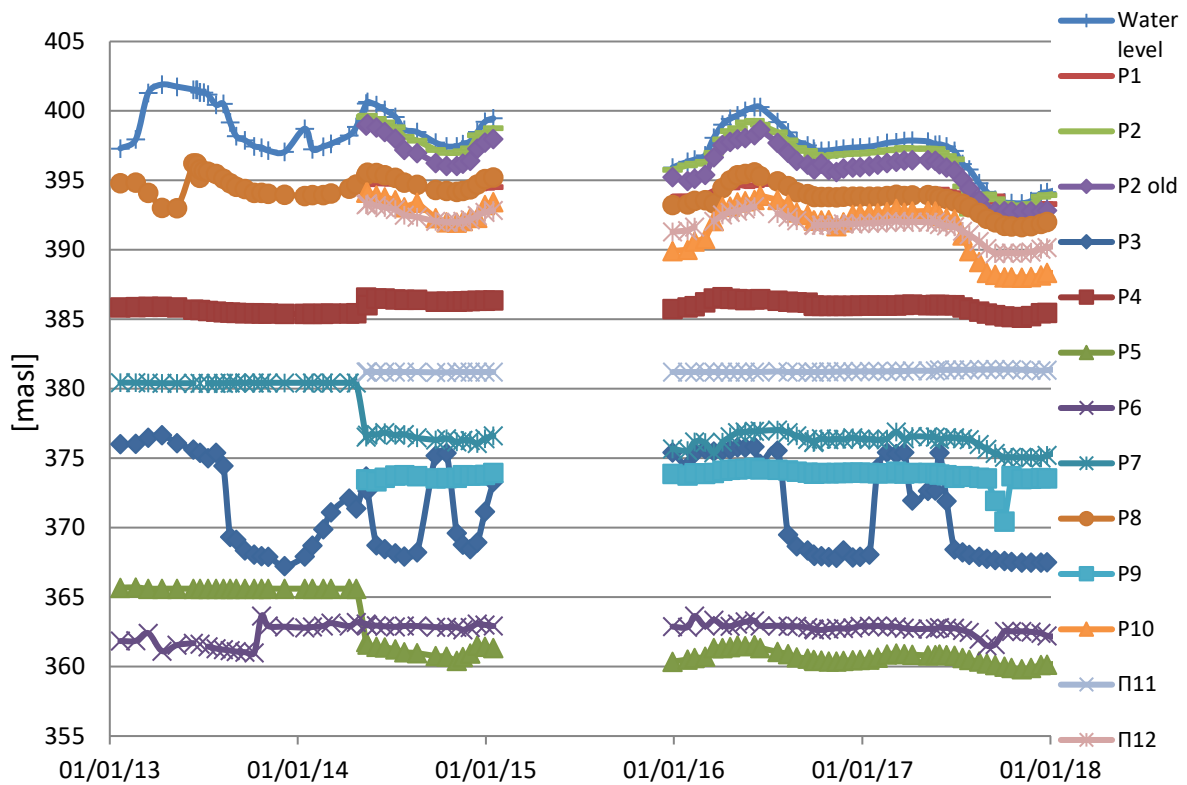
In most piezometers, the water level minimally oscillates (Figure 4). The water level in the piezometer P3 varies in correlation with the water level in the reservoir. After the inspection in 2013, an unexpected variation of the water level in piezometer 8 was noticed from February to June, which is probably related to the reservoir water level variations. After that more often measures were taken to better understand the condition of the downstream slope and to define the causes leading to wetting on the downstream slope.

Figure 4: Groundwater level variations for 5 years

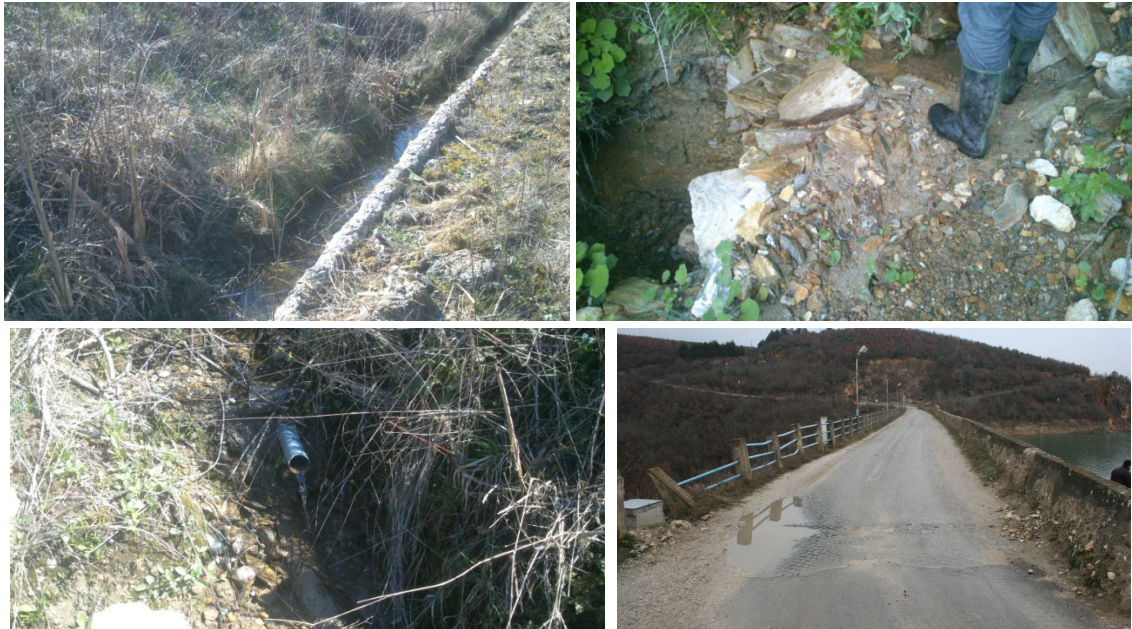
Visual monitoring of the dam and reservoir covers all possible manifestations of changes in terms of dam profile changes, slopes, surrounding terrain and reservoir banks. In 2013, wetting of bench 3 on the downstream slope (382.50 m a.s.l.) and spring water flow were observed. A line erosion with an open gully along the dam contact with the right groin was also observed. There was water retention on the dam crown with the possibility of infiltration in the downstream zone (Figure 4).

Figure 4: Wetting on the bench, gully on the right groin, sources and water retention on the dam crown.

Based on the above, it can be concluded that the wetting and water flow on the downstream slope most likely occurs through the body of the dam through already formed concentrated filtration flow paths, which are diffusely manifested on the surface of the slope.

Generally, it is not allowed the occurrence of any wetting or leakage of water through the dam body is the first sign of urgent action to revitalize such phenomena.

One of the possible technical solutions for revitalization is the construction of waterproof protection (geomembrane) on the upstream slope of the dam, properly "anchored" from the base rock to the dam crown. Another solution can be a clay-concrete diaphragm from the dam crown by injection into the base rock mass for prevention of infiltration under the dam or jet grouting in the dam and the dam base. All these solutions can be financially irrational because some require emptying the reservoir, proper capture of river water, and removal of the accumulated sediment in the area of the foundation of the upstream slope, so the user will not be able to use the water for several seasons. From a technical and economic point of view, the solution of grout curtain made by classical injection in the zone with the most unfavourable water permeability seems to be the most rational solution (Figure 7).

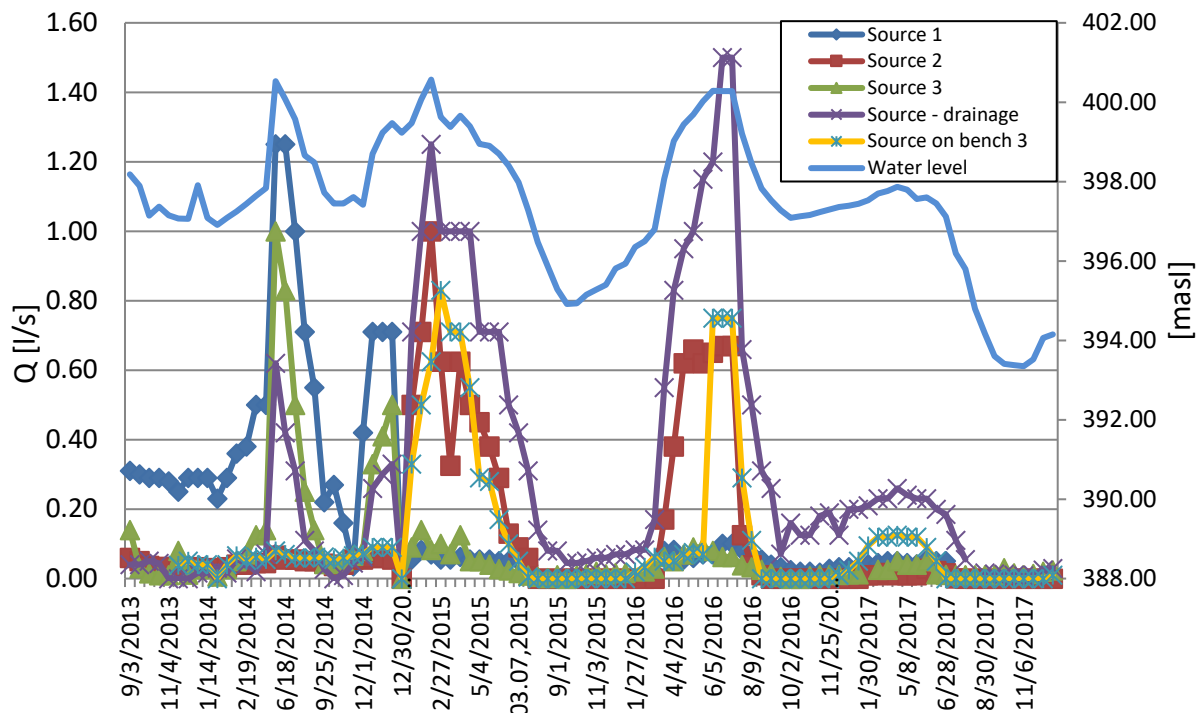
The change of water flow through the dam on the downstream slope is monitored in the springs No. 1, 2 and 3. Most of the time it is leakage water, but when the water table in the reservoir is above 397 masl, there is increased flow. The results from the monitoring are shown in the following diagram.

Figure 5: Spring flow variations for 5 years.

The water flow through the springs is directly related to the water level in the reservoir. For a maximum water level in the reservoir of 400 masl, the water flow rises above 1.0 l/s. Until the realization of the revitalization measures of the dam, the water level in the accumulation is kept relatively low.

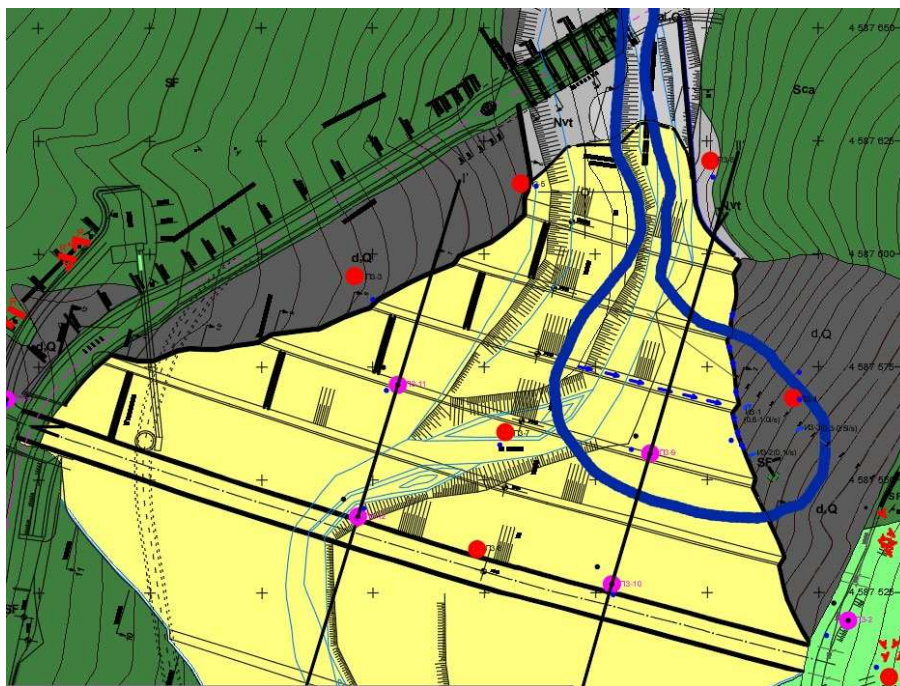
Figure 6: Layout of the wetting zone

From the investigations, it can be concluded that the geological conditions at the right base of the dam are very unfavourable (appearance of many cracked limestones with extremely increased water permeability) and with the absence of a grout curtain, there is direct infiltration of groundwater under and around the dam. This was confirmed by the appearance of springs on the right dam side after filling the reservoir. The grain size distribution of the material in zone 1 defines it as GFC, GFC/SFC with the permeability of $K_f = n \cdot 10^{-4} - n \cdot 10^{-3}$ cm/s, double increased moisture content, decreased compaction. There is also a possibility of suffusion and water transport through the investigation gallery for which there is no information about its condition. Assuming practically impermeability of zone 1 of the dam body, there is a high probability that the groundwater under pressure

transfers to the zone 2 through the extremely permeable rock masses – limestones and the contact with the schists, which can be one of the reasons for the appearance of water on the downstream slope.

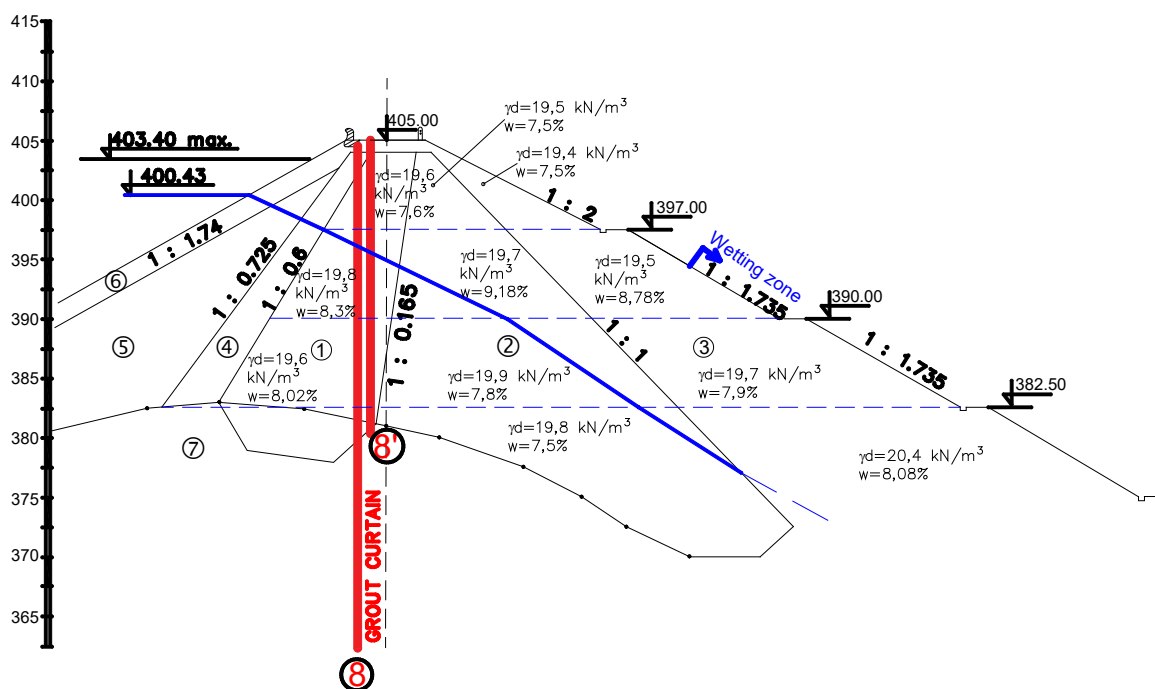
Figure 7: Dam cross-section: (1) impermeable core, (2 and 3) rockfill, (4) inclined filter, (5) stone part, (6) coarse stone coating, (7) base and (8 and 8' in red) two-row grout curtain.

The main task of the grout curtain is to reduce the filtration of water through the rocky environment, the dam body, as well as the contact between these two environments; preventing the formation of concentrated groundwater flows and suffusion, primarily in the dam body, which can directly contribute to the deterioration of the general stability (through reduced compaction, increased moisture content, reduced strength parameters of the embankment material, etc.); improving soil and rock parameters and decreasing the uplift capacity of the base. It is also expected to fill the pores in the zones with slightly increased water permeability which would achieve the required effect.

Regarding the dam body, the curtain belongs to a part of the deep and right side curtain. Deep down, the curtain in the base rock is brought to a practically impermeable environment with a water permeability $\leq 3 \text{ Lu}$. A two-row grout curtain is designed in the dam body due to the character of the material, while a single row is in the basic rock mass. The order (upstream and downstream order) implies time-independent construction in two phases. So the curtain has an investigative, current and controlled character. A bentonite-cement mixture is provided for the grout curtain.
