Restoration of the Elementary School "Johann Heinrich Pestalozzi"-Skopje

Dimitar Papasterevski*, Aleksandar Radevski

Faculty of Architecture, Ss Cyril and Methodius University, bul. Partizanski odredi 24, Skopje, Republic of Macedonia

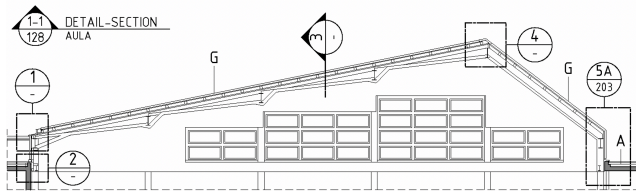
Figure 4: Detail-Section of Aula M=1:200

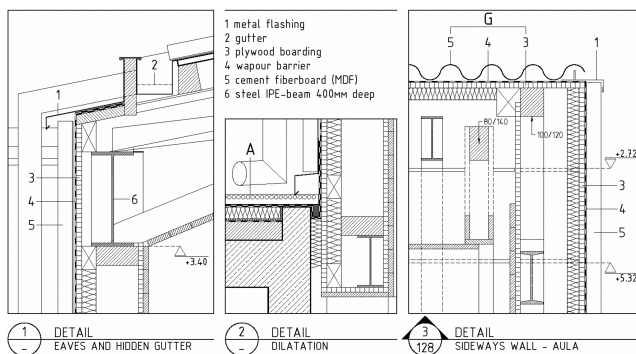
Figure 5: Typical architectural details of roof covering-Detail Section of Aula 1-1, M=1:20

In connection with the constant poor condition of the roofing and waterproofing, a complete set of new architectural details has been developed for all the critical positions. A comprehensive reconstruction has been proposed for the flat non-trafficable roof terraces, which implies the process of extracting all layers up to the finishing floor structures or subfloors. The process of reconstruction further implies cleaning and remediation of all horizontal and vertical gutters, restoration of perimeter sheet flashing, restoration and remediation of dilatations, and protection of the vertical soil pipes from the toilets appearing on the flat non-trafficable roof terraces. The reconstruction covers the roof pitch of the Aula and the gym with complete replacement of the existing roofing material after the examination of the existing subfloors and particularly the thermal insulation (Figure 5).

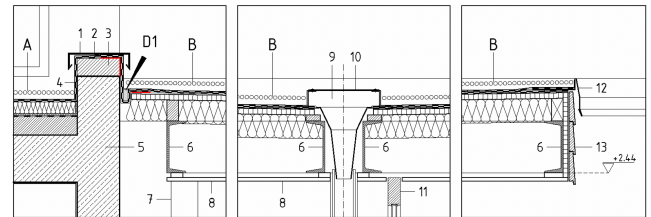
Figure 7: Typical architectural details-Entrance Proch Classroom, M=1:20

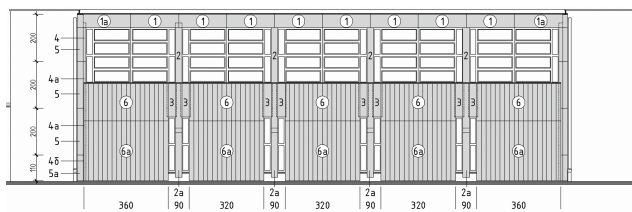
The façade's envelope is comprised of two basic types of construction materials: reinforced concrete canvas as natural concrete as well as partial application of vertically mounted corrugated asbestos-cement slabs (Aula and gym). The gravest issue of the façade's envelope is the corrugated asbestos-cement slabs Salonite or Eternit. In compliance with our current regulations and environmental standards, the application of these materials is not permitted and would inevitably obligate their complete and immediate replacement with similar, environmentally friendly material (fibercement boards or similar tiles (Figure 8)).

Figure 8: Detail of west elevation–Gym, specification of fibercement boards on façade's envelope
