## **A CASE HISTORY OF HAZARDOUS WASTE FORMED IN A CHEMICAL PLANT ACCIDENT**

**Abstract.** Hazardous waste composed of mixture of chemical products, such as partially burned and/or degraded raw materials, semiproducts and final products, and pieces of production hall destroyed in the explosion, estimated to a total of ca 250 tons, was urgently removed from a plant location and disposed in a nearby cement industry yard. Unfortunately, instead of planned 3 to 6 months, it took more than 10 years before the further step towards permanent disposal was realised. During these 10 years a lot of efforts aimed to provide a proper solution that will meet the existing legal, environmental, and other regulations were done. Due to lack of experience, limited finances and other organisational inconsistency, all of the efforts were unsuccessful. Finally, when the temporal site location became an obstruction for cement raw-material mining, a solution was found in dislocation of the provisory landfill to an adjacent but already exhausted corner of the mine field. First of all the existing cell was carefully opened and checked for eventual emission of dangerous gases or vapours. When this possibili

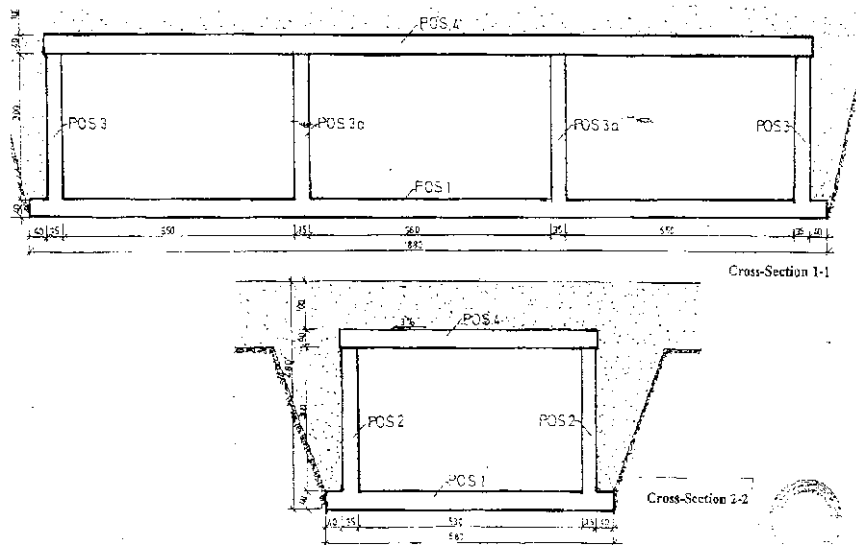
Fig. 1. A schematic of sarcophagus lay-out and cross-section

In absence of any hazardous waste treatment facilities, facing an urgent need to render the site location to its original purpose and having in mind the fruitless search for permanent location, we concluded that a sarcophagus is the optimal solution. Having the authority's approval, a 3-compartment concrete shell was designed, constructed and coated waterproof. The site's layout and cross-section are given in Fig. 1. In Figs 2 and 3 photos are given of the real object before and during its filling with the mixture of hazardous waste and soil from the temporal site.

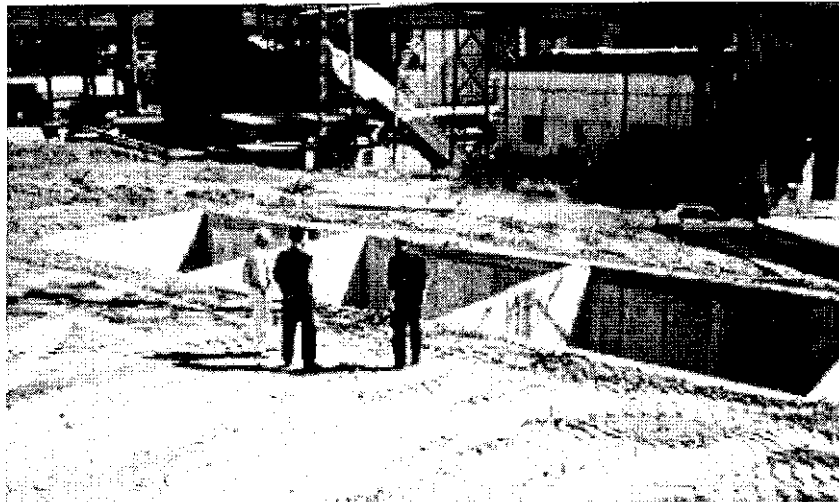
Fig. 2. Empty sarcophagus

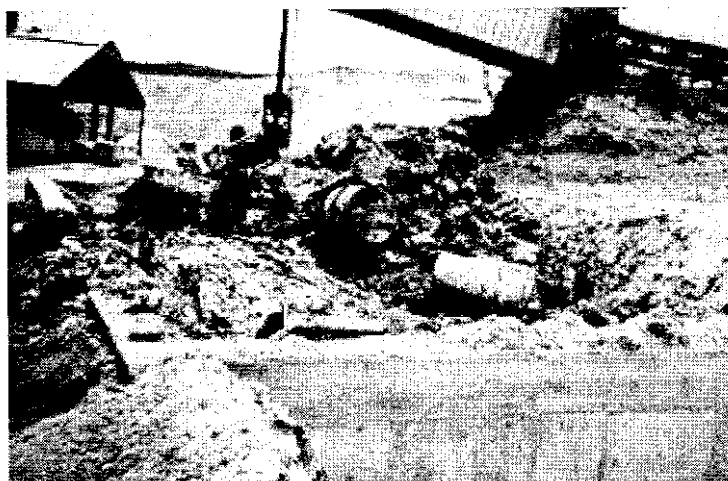
Fig. 3. Sarcophagus shell filled with a mixture of hazardous waste and soil

The waste's removal and transportation were done with maximum care in order to avoid any possibility for further contamination. Finally, the concrete boxes were covered with proper concrete plates, thus forming the planned sarcophagus.
