RESTORATION OF THE ELEMENTARY SCHOOL "JOHANN HEINRICH PESTALOZZI"-SKOPJE

Dimitar Papasterevski¹

Aleksandar Radevski

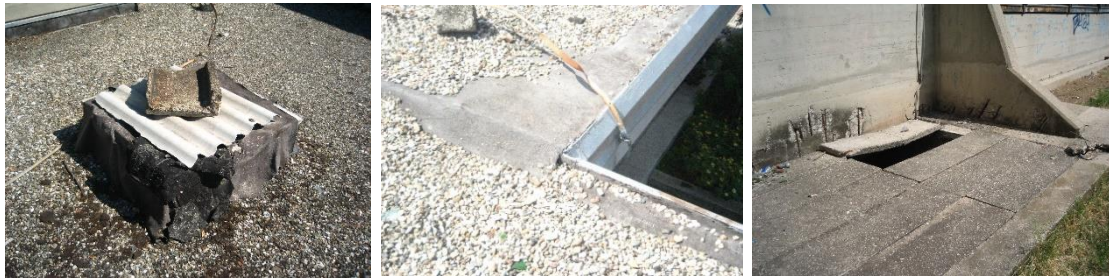
(gutters, sheet flashing, dilatations, lightning rod installations, etc.), caused a serious damage. Another alarming issue was the dilapidation of applied materials and damages caused by the rainwater penetration. The domes and the inclined fanlights above the classrooms on the north side were in a severe critical condition, as well as all the wooden windows. Damage was additionally observed to a part of the reinforced concrete canvas throughout the entire building. A leakage of the roof structure caused a permanent damage of the floors in the gym. The inspection revealed unprofessional partial interventions on the flat non-trafficable roof terraces in the dilatation areas as well as in all areas where rainwater leakage 'appeared'. (Figure 3)

Figure 3: Damage of roof segments and façade's concrete walls

Moreover, there was a critical damage on the gym and Aula envelope constructed from asbestos-cement slabs as well as on part of the sheet flashing with the dilatations around the Aula. Most of the gutters on the flat non-trafficable roof terraces were permanently damaged or inoperable, which also caused serious damage to the waterproofing due to rinsing of the protective gravel layer.

In connection with the constant poor condition of the roofing and waterproofing, a complete set of new architectural details has been developed for all the critical positions. A comprehensive reconstruction has been proposed for the flat non-trafficable roof terraces, which implies the process of extracting all layers up to the finishing floor structures or subfloors. The process of reconstruction further implies cleaning and remediation of all horizontal and vertical gutters, restoration of perimeter sheet flashing, restoration and remediation of dilatations, and protection of the vertical soil pipes from the toilets appearing on the flat non-trafficable roof terraces. The reconstruction covers the roof pitch of the Aula and the gym with complete replacement of the roofing material after the examination of the existing subfloors and particularly the thermal insulation (Figure 5).

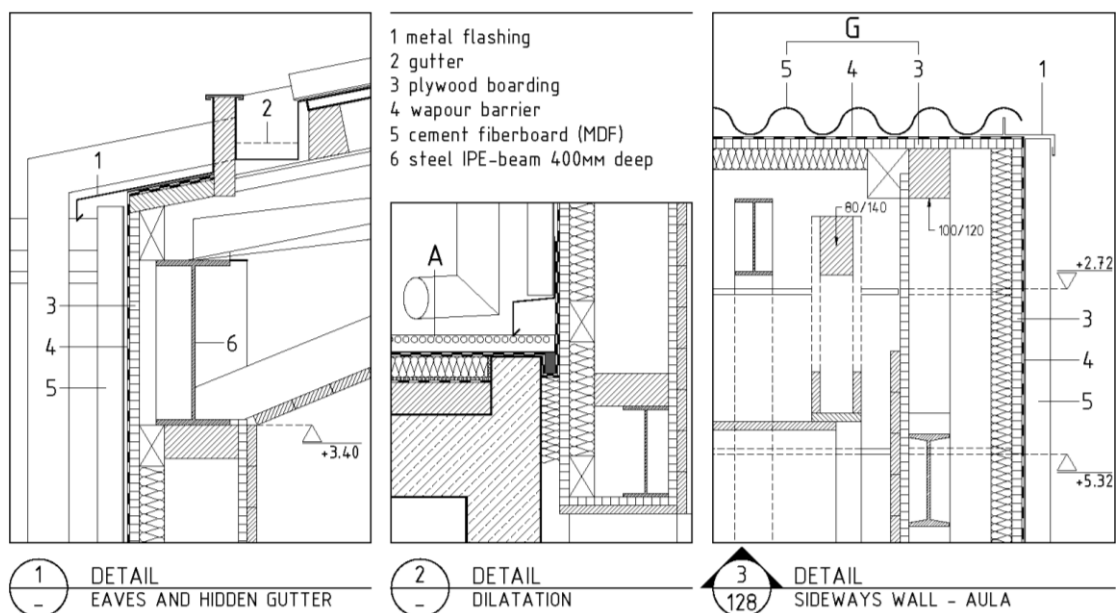
Figure 5: Typical architectural details of roof covering – Detail Section of Aula 1-1, M=1:20

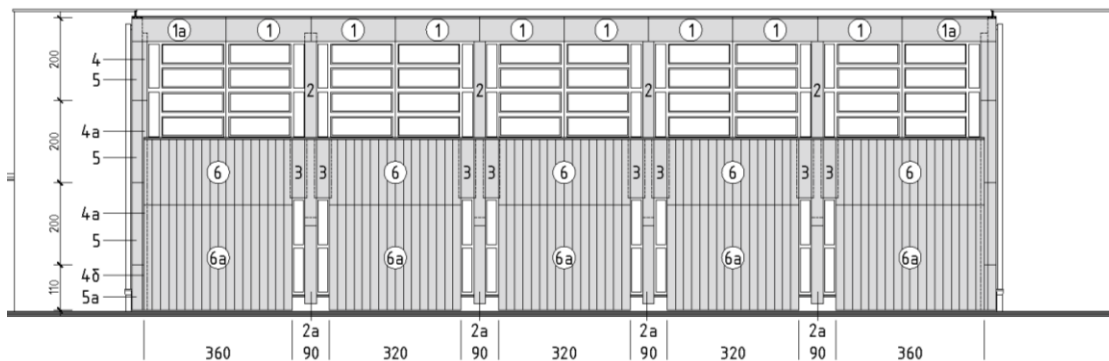
Figure 8: Detail of west elevation – Gym, specification of fibercement boards on façade's envelope

The façade's envelope is comprised of two basic types of construction materials: reinforced concrete canvas as natural concrete as well as partial application of vertically mounted corrugated asbestos-cement slabs (Aula and gym). The gravest issue of the façade's envelope are the corrugated asbestos-cement slabs Salonite or Eternit. In compliance with our current regulations and environmental standards, the application of these materials is not permitted and would inevitably obligate their complete and immediate replacement with similar, environmentally friendly material (fibercement boards or similar tiles (Figure 8)).
