The need of integrated renovation of the existing building stock in North Macedonia

Roberta Apostolska, Veronika Shendova and Golubka Necevska-Cvetanovska

Institute of Earthquake Engineering and Engineering Seismology, IZiIS, University Ss Cyril and Methodius, Skopje, North Macedonia

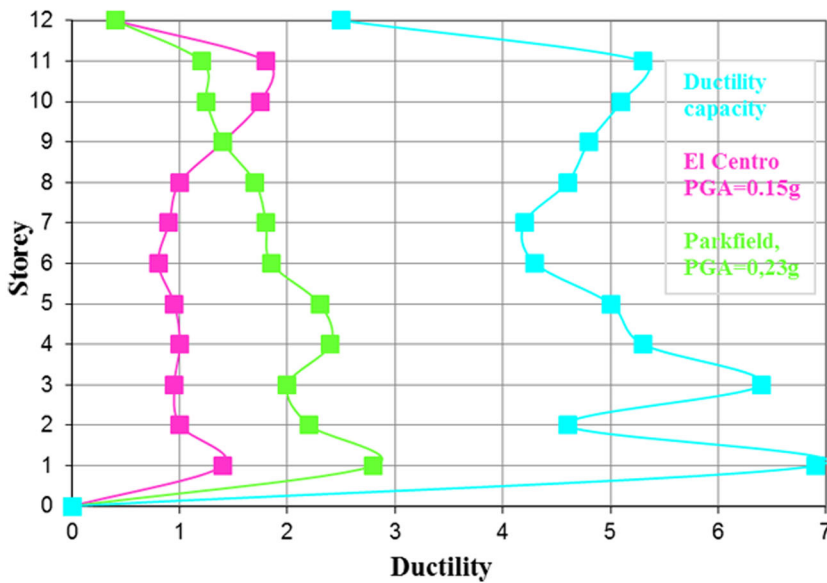
**Required ductilities in Y-Y direction
- strengthened state-**

Figure 2. Figure 2a. RC building tower 5 - layout of the solution for retrofitting. Figure 2b. RC building tower 5 - demand versus capacity in terms of ductilities.

The strengthening solution anticipated both, the insertion of columns with RC jackets ($d=10$ cm) and concrete compressive strength of 40 MPa and also incorporation of new RC walls with $d=15$ cm up to the tenth story (two walls in longitudinal and four in transversal direction) (Figure 2a). Distribution of the ductility demands versus capacities along the height of the structure is given in the Figure 2b.

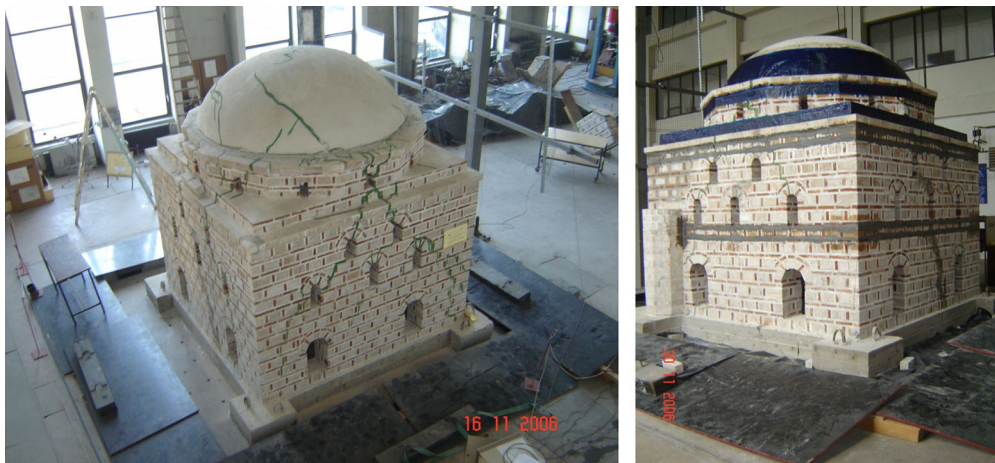
Figure 5. Figure 5a. Mustafa Pasha Mosque - model of original state. Figure 5b. Mustafa Pasha Mosque - model of strengthened state with CFRP bars and wrap.

The main principles of seismic strengthening of the Mustapha Pasha Mosque in Skopje were: (i) application of new technologies and materials, (ii) reversibility and (iii) invisibility of the applied technique. Based on the submitted architectonic data, the investigations of the soil conditions, the investigations of the characteristics of the built-in materials, visual inspection of the structure as well as previous experimental investigations of a mosque model (Figure 5a), a solution for repair and strengthening of the existing structure is elaborated (Figure 5b), followed by a detailed analysis and computation of the bearing system under gravity and seismic loads (Shendova et al., 2012).

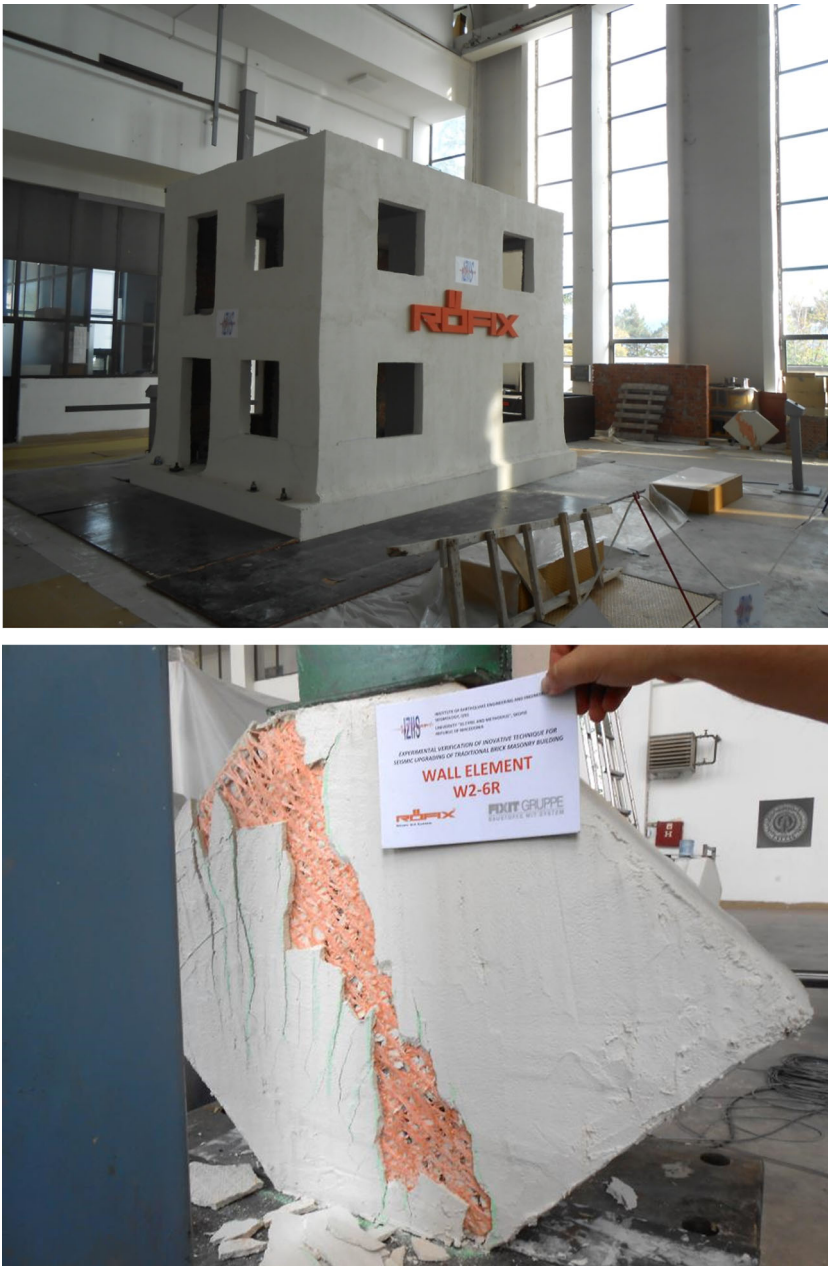
Figure 6 Figure 6a. ROFIX case study - retrofitted model on shaking table. Figure 6b. ROFIX case study - failure mechanisms of strengthened wall element.

Providing both the earthquake resistance and energy efficiency of existing buildings was the triggering issue for developing an innovative technology called System ROFIX SismaCalce by the company ROFIX, member of the of Fixit Gruppe from Austria. It combines the system ROFIX Sisma for seismic upgrading and the multilevel ROFIX system for thermal insulation; applied together they enable earthquake resistant and completely thermal insulated structure. The testing programme which main goal was experimental investigation of the efficiency of this newly developed integrated methodology was carried out in IZiIS (Figures 6a and b) (Shendova et al., 2013).

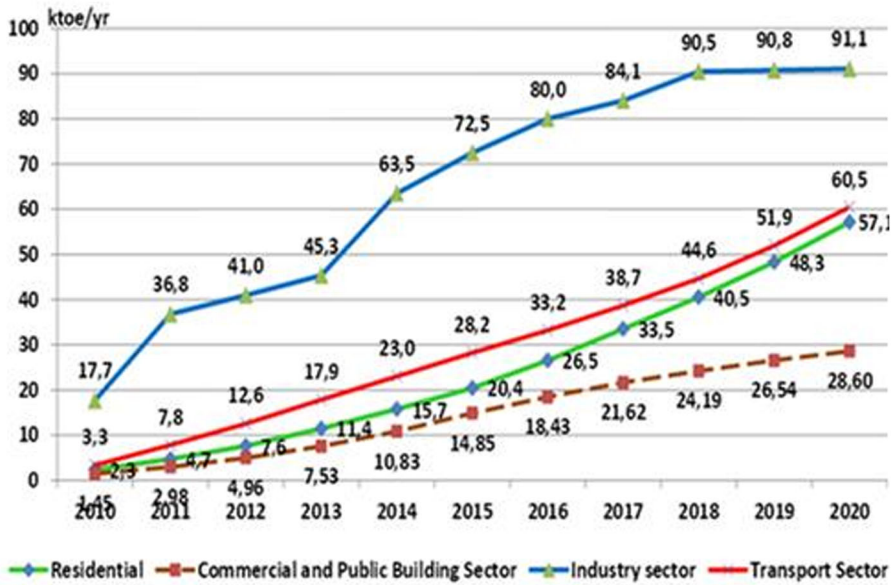
Figure 7. Goals in potential of energy savings according to the Strategy of EE, up to 2020.

Following emerging needs for smart energy society, the ‘First energy efficiency action plan (EEAP) of the Republic of Macedonia by 2018’, was developed pursuant to the directive 2006/32/EC (Ministry of Economy, 2011). National indicative energy saving targets is presented in Figure 7 (Apostolska & Samardziovska, 2014). These targets should be achieved through set of comprehensive energy efficiency improvement (EEI) program and measures. The most efficient ones in the residential sector are adoption and enforcement of building energy codes and EE retrofits in existing buildings.

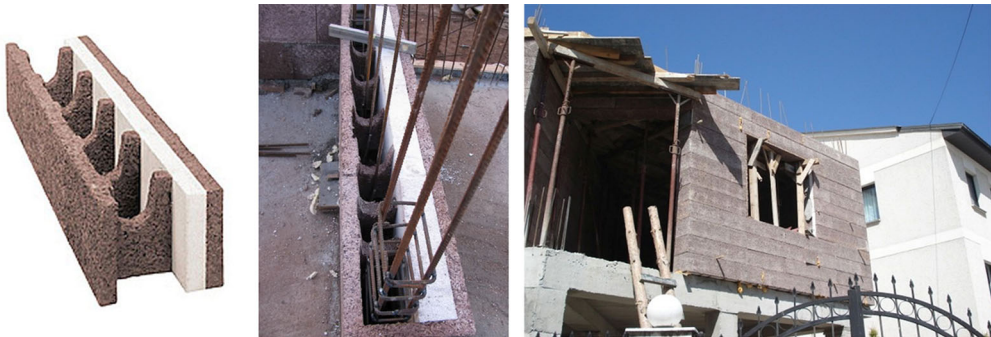
Figure 8. a) Hollow wood-chip concrete blocks with integrated insulation; b) Hollow wood-chip concrete blocks - placing reinforcement in the wall; c) Hollow wood-chip concrete blocks – mounting elements.

Another example of positive practice, although in the very begging phase in North Macedonia, is building ecologically with hollow wood-chip concrete blocks (Figure 8a). These blocks are characterized with excellent noise insulation, heat storage and vapour diffusion, as well as fire resistance and earthquake safety (Figures 8b and c) due to their compact core (Samardziovska & Apostolska, 2016).
