Inclined Aqueduct of Skopje: A History in Brief and Preparation for the Future

Keywords: *Aqueduct; Inclination; Swelling; Stabilization; Micro-piles*

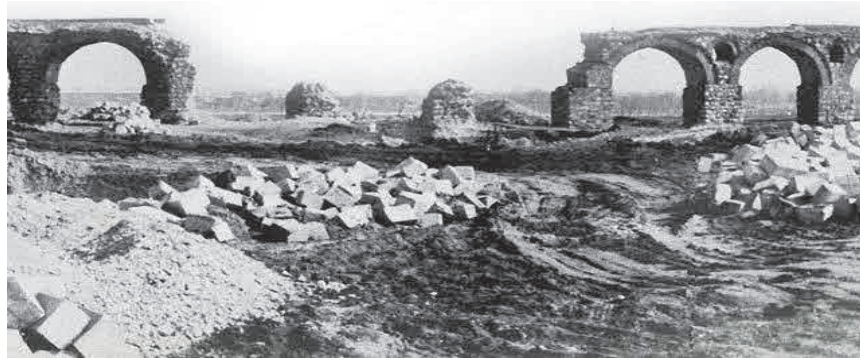
Figure 2 *Devastation after military exercises*

Unfortunately, it has suffered destructions, and recently two inclinations have appeared: towards east at one section long 25 m, and towards west at other section with similar length. Their size is up to 60 cm, i.e. 10% of the height, which is tremendous and is threatening the existence of the aqueduct. In order to determine the reasons for such damages, review of historical and existing technical documentation was realized, geotechnical drillings have been conducted at the location, above- and underground structure conditions were mapped, soil samples were taken for exhaustive laboratory tests and office works were performed for selection of appropriate stabilization measure. It has been found that there are very heterogeneous soil layers beneath and along the structure, part of which have swelling capacity high enough to lift up the aqueduct. This is appropriate for the upper layers, which are quaternary sediments – clay and silt, while the deeper ones consist of sand and gravel, which, together with the swampy location, leads to great differential settlements. Also, Skopje has regularly suffered from very strong earthquakes in the past and moreover: two tectonic rifts were detected just under the aqueduct! Not to leave behind, the human factor is also included: four of the columns were ruined and reconstructed later because of military exercises, while having been built in the time of the Ottoman Empire, gullible people thought it was a good idea to dig for gold, around, under and in the columns. As the pillars are continued in the ground same as above, there is no specific foundation construction of the Aqueduct. This might be other reason for the damages, where the most alarming is the serious eccentricity that the columns are confronting: more than 0.5 m for few of them. As mentioned above, what demands special attention are the size and direction of the current inclinations: one group of columns are inclined towards west, among which the most inclined is column C13, for 53 cm, while among those inclined towards east the most endangered is column C26, with 22 cm. Other challenges are the flow of underground water, which has undermined the pillars, and the very bad actual construction of the above part of the pillars

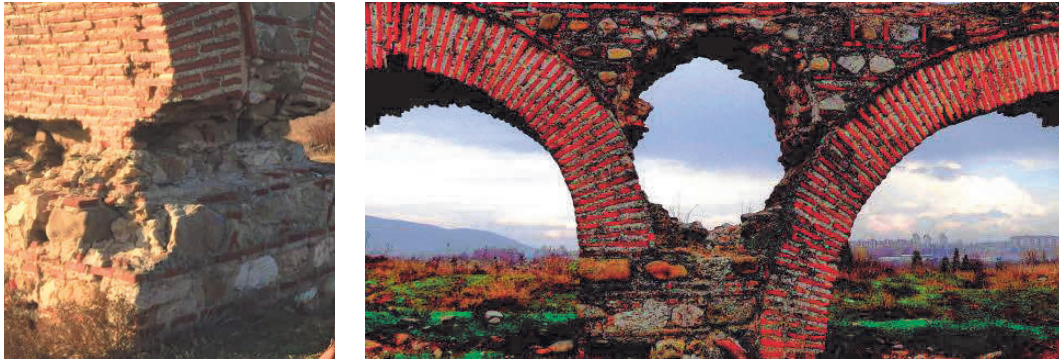
Figure 3 *Human factor in destroying the pillars of the Aqueduct*
