АНАЛИЗА НА ПОПЛАВНИ ВОДИ НА РЕКАТА ЗРМАЊА ВО ОБРОВАЦ (ХРВАТСКА)

ANALYSIS OF THE RIVER ZRMANJA FLOOD WATERS IN OBROVAC (CROATIA)

Summary

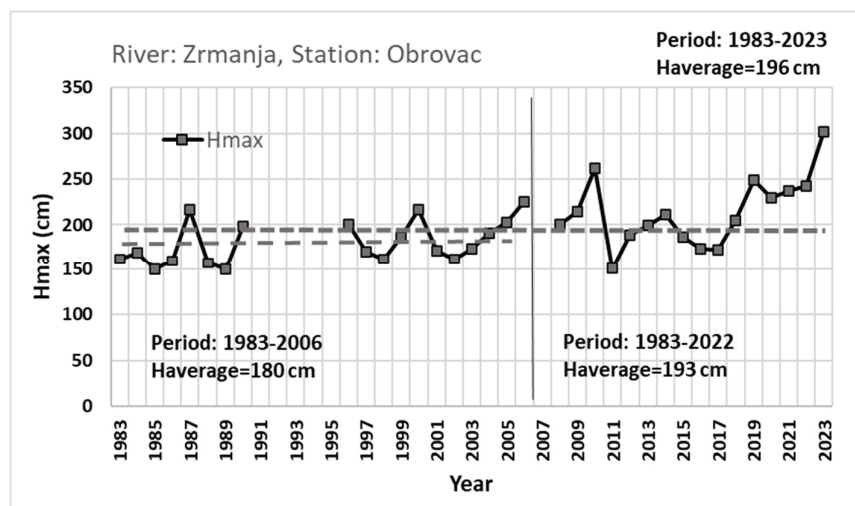
Figure 2. Series of maximum water levels in Obrovac (the Zrmanja River)

Figure 2 shows the maximum water levels of the Zrmanja River in Obrovac since the beginning of measurements.

Three periods should be observed in the past. The first from 1983 to 2006, when the construction of several infrastructure facilities on the shores of Obrovac began. Then, the second period from 1983 to 2022 and finally the third period from 1983 to 2023, in which the absolute maximum was recorded. Of course, for the mentioned periods the basic statistics differ, and they are presented in the table.

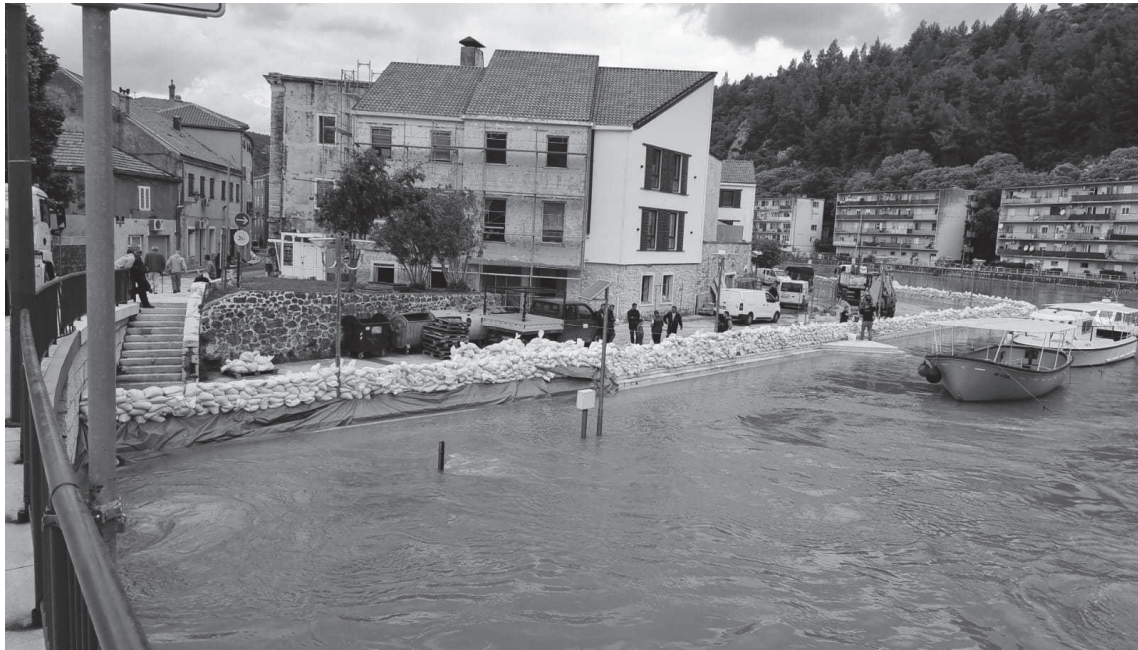
Figure 3. Flood protection on the left bank of Zrmanja in Obrovac (May 2023) (photographed by I. Peša)

With the raising of the Zrmanja river level in Obrovac (in May 2023), additional flood defense protection began (by stacking sandbags) (Fig. 3). However, such a large water wave could not be defended with temporary measures. Both banks of the Zrmanja River in Obrovac were flooded, affecting around 50 residential and commercial buildings (Fig. 4). The maximum water level in Obrovac (302 cm) remained almost the entire day (May 15), after which it slowly began to decrease. In such extreme conditions, the river level was 40-50 cm higher than the fixed protective structures (defensive walls).
