TRACK GEOMETRY DEGRADATION AND MAINTENANCE OF THE RAILWAYS

This paper studies track deterioration from geometric aspects and its influencing factors with a case study for railway line of pan – European Corridor 10 on the territory of North Macedonia.

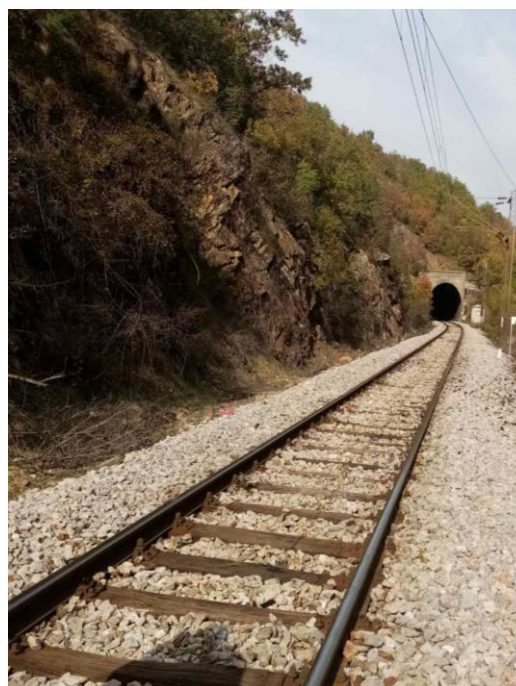
Figure 2. Corridor 10 on section Skopje – Veles
Source: Propection in situ

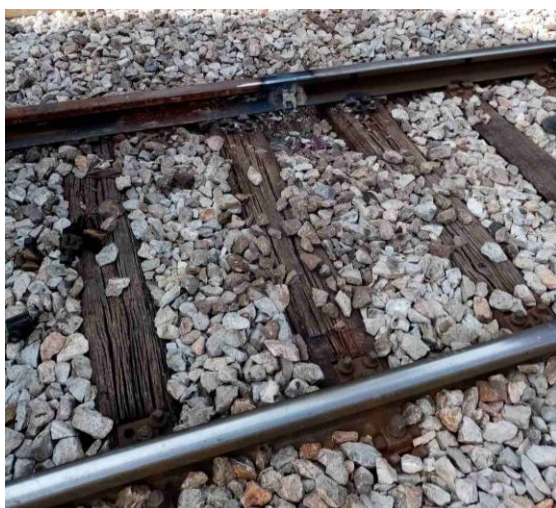
The total railway track consists of continuous welded rails (CWR). The most used rail is S49 on 97,3% of track length and of 2,7% of rail length have rail type S54 (sections line between stations Tabanovci – Kumanovo and Romanovci – Miladinovci).

The timber is dominant with around 89% of total number of 329 727 sleepers on railway track of Corridor X. The normal sleeper spacing is between 600 - 650 mm.

The most wide - spread fastenings system on the track is rigid K-system for each section where the timber sleepers are set and elastic fastenings SKL-14 with greater elasticity in the case of prestressed concrete sleepers.

The ballast is constituted from crushed limestone with grading of 25/60 mm for sections between railway stations.

The thickness of the ballast bed is estimated 30 to 35 cm measured from the underside of the sleeper. The ballast is contaminated frequently by attrition of the ballast material or upwards penetration of fine particles in the form of a clay mixture or slurry.

Figure 3. Superstructure with railway track of CWR
Source: Prospection in situ

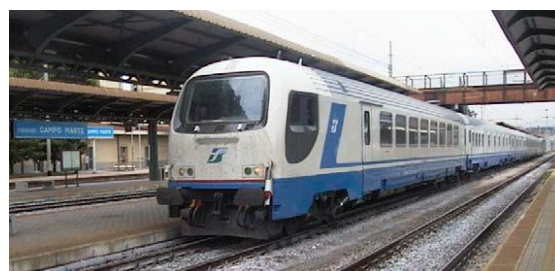
measuring system. This consists of an inertial navigational measuring system with integrated GPS positioning and a dual optical gauge measuring system. Track geometry faults with wavelengths up to 200 m can be recorded, regardless of the measuring speed [8].

Figure 4. Mermec measuring vehicle

The track geometry measurements of the railways on the territory of North Macedonia were carried out by measuring vehicles of the company Mermec (Figure 4) in 2010 and 2013.

- track gauge - the distance between the inner surfaces of the head rails measured 14 mm lower than the head tops,
- cross level/cant - difference in the height of rail heads in one cross section,
- twist - difference in cant on the base length of 5 m,
- alignment (D1 and D2) - horizontal deviation of the rail head from a base line (10 m long) measured independently for both rails,
- longitudinal level (D1 and D2) - vertical deviation of the rail from a base line made by points of tangency of 2 wheels with the rail (base distance equals to 10 m). It is measured independently for both rails.
