## RUT APPEARANCE ON PAVEMENT SURFACE AND MEASUREMENTS ON MOTORWAY A-4 IN MACEDONIA

### Abstract

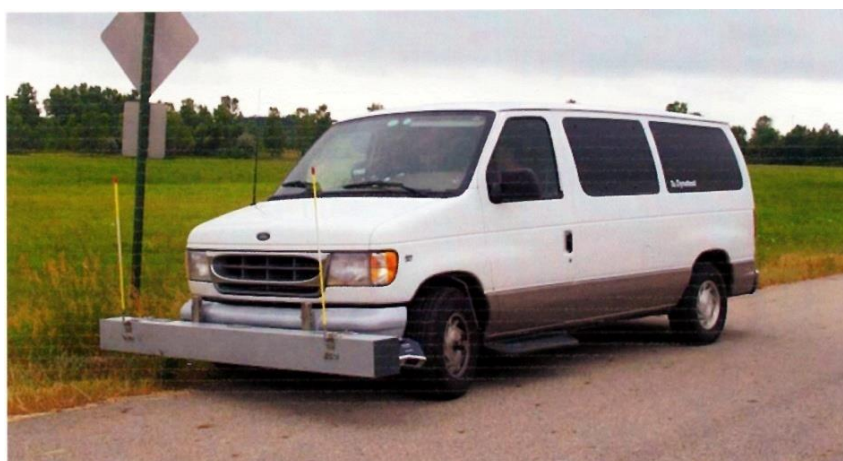
Measurements of evenness were done on the motorway A-4, as part of the international road E-65 at 15 km length with the measuring apparatus, high-speed inertial profilometer, The Dynatest Road Surface Profilometer, which according to studies conducted in the United States, represents the most precise measurement apparatus for measuring evenness of the pavement surface (Fig. 4) [9].

*Fig. 4: Inertial profilometer type: The Dynatest Road Surface Profilometer 5.051 Mark II*

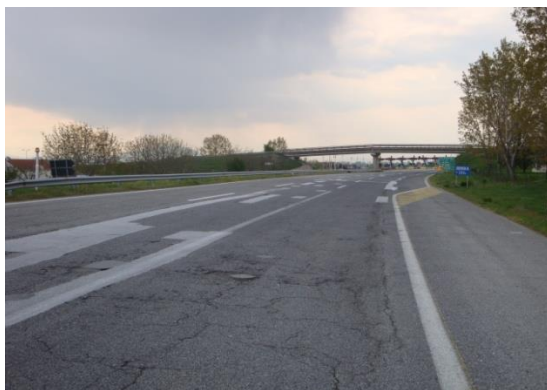
*Fig. 11: Beginning of the motorway A-4*

Several taken photos (Fig. 11 - 16) of the characteristic places on the motorway are presented below. Deformations like ruts with different sizes, are visible on all sections of the motorway [15].

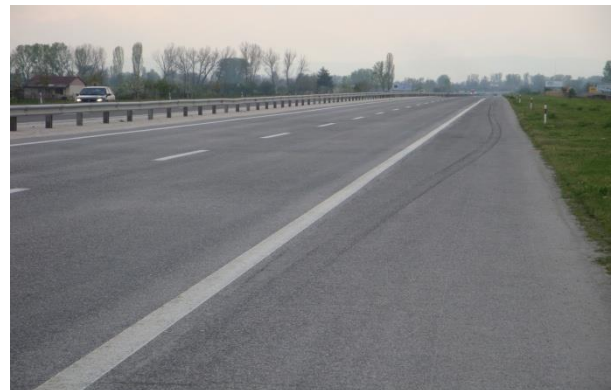
*Fig. 12: Ruts appearance*

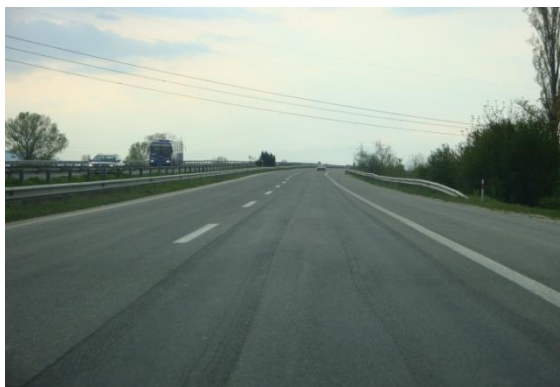
*Fig. 13: More evident ruts on climb*

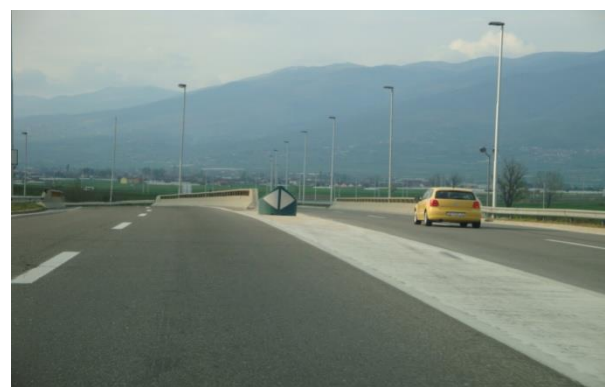
*Fig. 14: Ruts appearance*

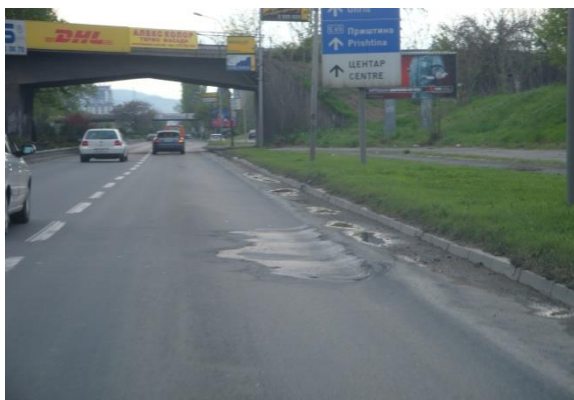
*Fig. 15: Max. ruts size*

From the measured values, as well as from the conducted evaluation of the pavement surface condition, we may note that the plastic deformations - ruts have appeared on all sections, and situation is quite heterogeneous. The ruts depth ranges from 0,00 mm to 29,90 mm (on the M301D).

It can be concluded that the factors with significant influence on the appearance of transverse unevenness - ruts depth are: traffic load, climatic conditions, the quality of the pavement surface and quality of the used materials. Adding the additives (such as Polymers) in the composition of the asphalt mixture - modified asphalt concrete, contributes to improved endurance, and these asphalt mixtures have greater resistance to ruts appearance at specified temperature, than conventional asphalt mixtures [16].

As recommendations for improvement of the road network in Macedonia within the Pavement Management System, the following measures can be proposed: adoption of criteria for determining the ruts depth, regular measurements of unevenness - rut depth, evaluation of the condition of transverse evenness and measures for their rehabilitation, use of modified asphalt concrete, improving the drainage capability of driving areas. These are important factors that affect the creation of plastic deformation on the road surface which will finally result in reduction of the potential aquaplaning and increase in the road safety.
