# **IMPLEMENTATION OF ROAD SAFETY AUDIT IN THE DESIGN PROCESS OF THE STATE ROAD A1, SECTION DRENOVO-GRADSKO**

This paper will present part of the remarks identified by Road Safety Audit in the design documentation related to the Drenovo-Gradsko road, and the methods and technical measures necessary to overcome them.

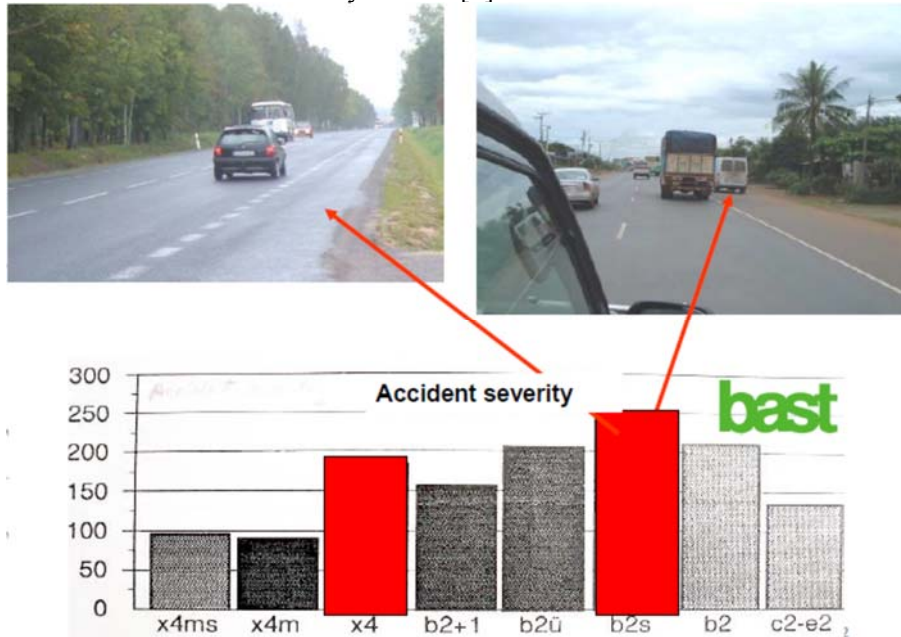
As in compliance with the BAST research, conducted in 2001, the highest number of traffic accidents occur on a 1+1 cross-section profile with a wide stopping lane. Such roads are often used by drivers as narrow four-lane sections. Besides the use of the road as a four-lane one, overspeeding appears

as a secondary problem especially in roads with a low traffic volume. The traffic accidents are often very serious [5].

Fig.3. BAST Example of most dangerous cross section

An improvement recommendation is the use of a medium-belt 2+1 profile between the two directions.

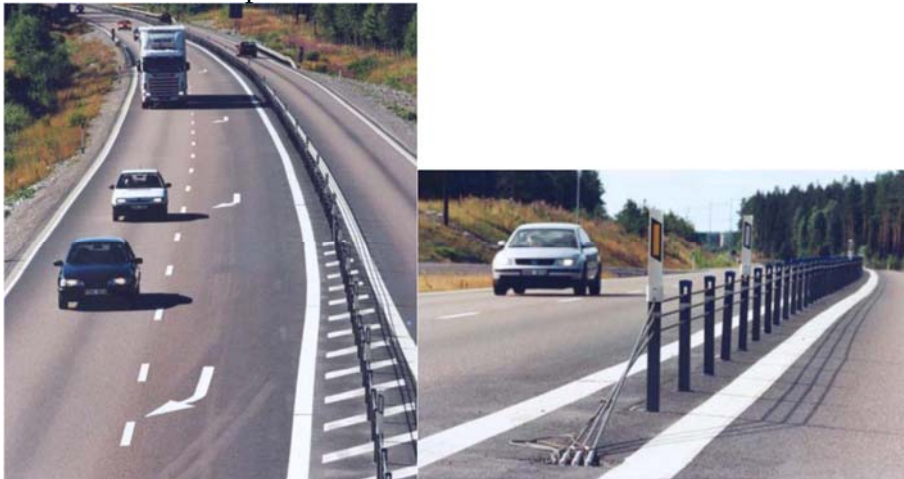
- Swedish approach - the physical separation is provided for a centre cable barrier.

Fig.4. Typical 2+1 roadway with centre cable barrier in Sweden

It is recommendable to apply the Swedish approach with physical separation for this road section, as a high level of driving culture and an increase of fines is necessary for the application of the German approach.

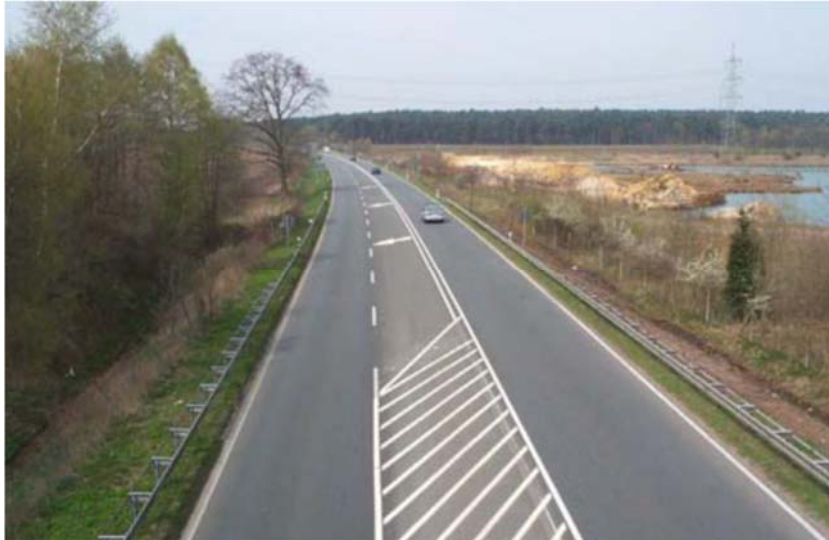
- German approach – the separation is provided for by the wide bolded road beacons on the pavement.

Fig.5. Typical 2+1 roadway in Germany

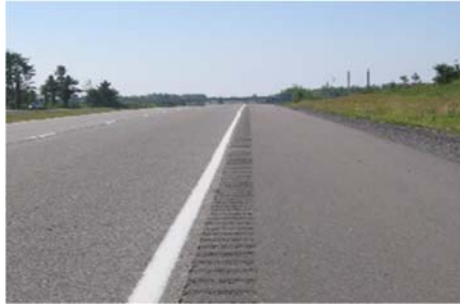
Fig.6. Example of edge rumble strips

In the case of such a slipping it is recommended to apply profiled lines or edge rumble strips warning the driver about the possibility to slip off the pavement and help him correct the driving.

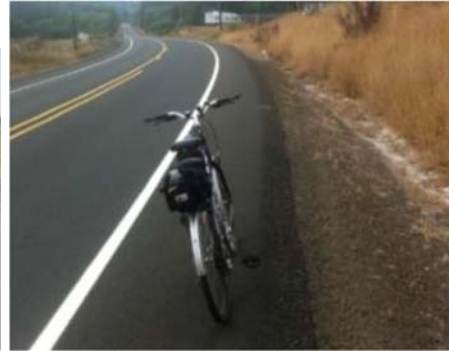
Fig.7. Example of narrow hard shoulder

Another possible method to deal with the problem is to use a 1+1 profile with a narrow stopping lane, maximum 1.0m wide. The overall width of the road will be 10 to 11 m.

The narrow stopping lane would be sufficient for urgent stoppage of the vehicles, to stabilize and return the vehicle to the main driving lane upon its incidental slipping out of the pavement.

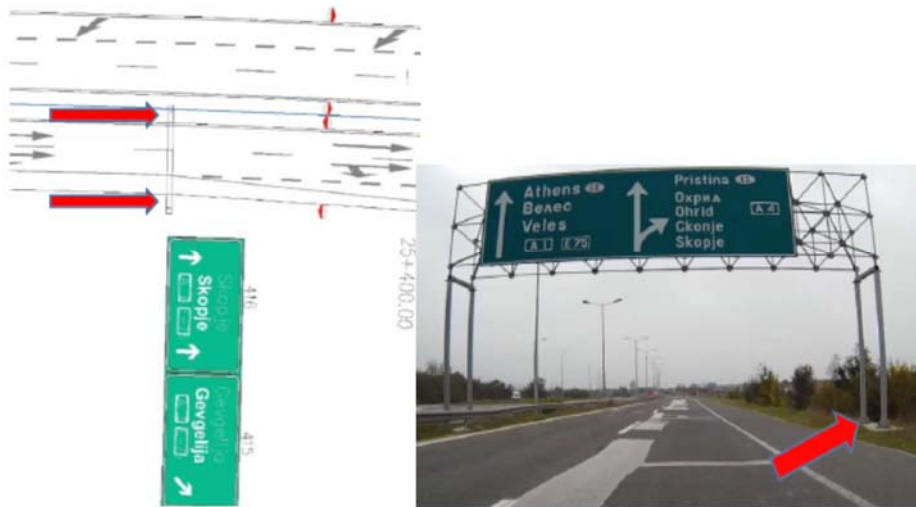
On locations with dangerous barriers as portal posts, overpass pillars, lighting posts etc., positioned in the vicinity of the carriageway borders it is necessary to provide for a protecting fence in order to protect the vehicles.

Fig.12. Unprotected portal posts left and right side on chainage

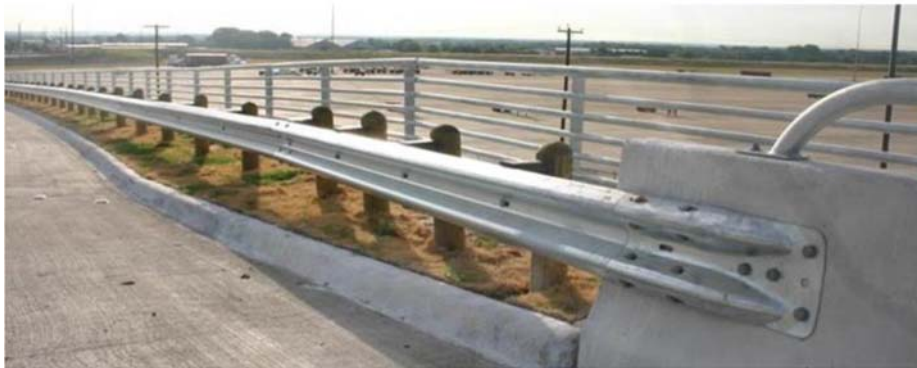
The anchorage of the fixed roadside barriers, as are walls or similar flat-end constructions in the vehicle movement direction is carried out so as to be gradually tighter until the barrier (the transition is achieved with harder protective barriers).

Fig.15. Example of transition between concrete barrier and guardrail

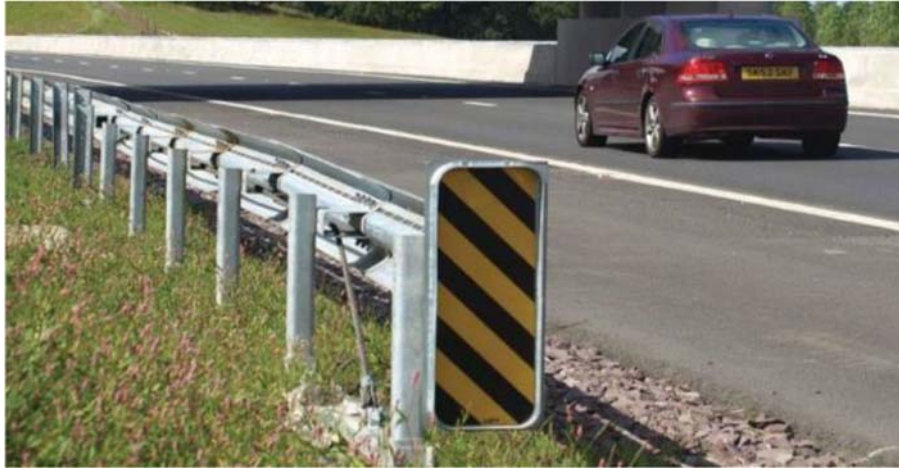
The boards of the elastic fence end at an angle where there is no final terminal. On the basis of a large number of impact tests and road accident statistics it was concluded that such an inclined ending is insecure and creates the danger for the vehicle to overturn upon a collision with them.

Fig.16. Example of end terminal

It is recommendable to include a final terminal, stretching in the direction of vehicle movement, in the construction of the initial part of the protecting fence, as the final terminal has the quality of amortizing the vehicle impact.
