Seismic performance validation for RC building structures damaged by Durres earthquake, Mw6.4, 26 November 2019, Albania

Abstract

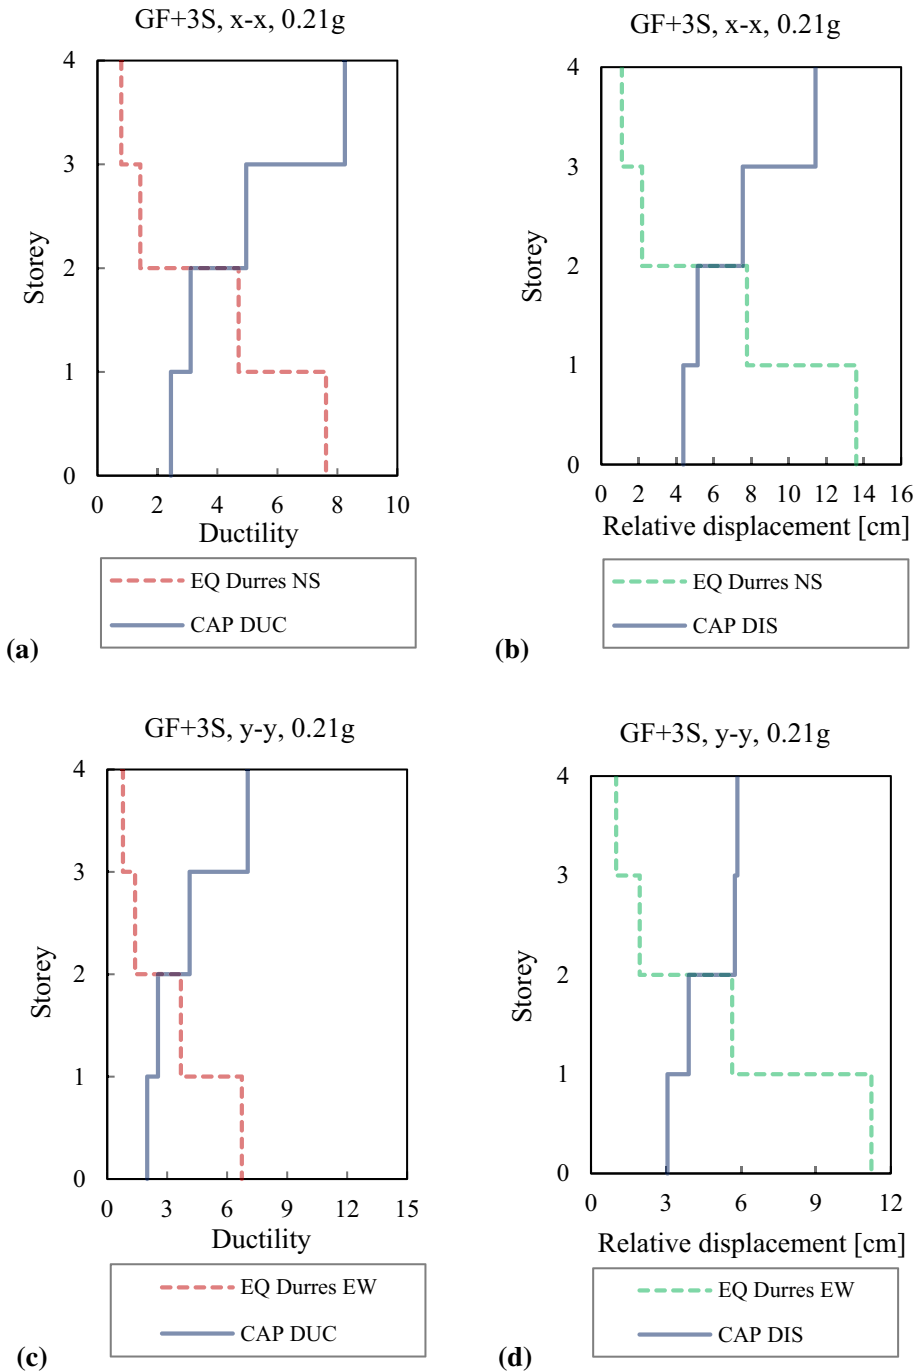
3.3.1.1 Low-rise regular frame structure The nonlinear dynamic analysis was based on input data from the equivalent seismic force analysis. Figure 12 shows the relative story displacements and ductility demand in x-x and y-y direction for the design earthquake ($a_{\max} = 0.21$ g). The ductility demands were defined by use of the methodology and a corresponding package of computer programs for performance evaluation of existing structures, (as mentioned in item 3.1). The results showed that, in the case of this type of structures, the capacity at the first and the second level was exceeded in both x and y directions. A particular difference was observed at the first level where the ductility capacity was exceeded almost thrice, while the displacement capacity was exceeded more than thrice. Due to these differences, heavy damages to nonstructural elements with possible occurrence of damages to structural elements in the lower storeys as well as possible disturbance of the global stability of the structures were expected to occur (Fig. 13).

Fig. 12 Graphical presentation of the results for LRR-FS. **a** Storey–ductility in x direction; **b** storey–displacement in x-direction; **c** storey–ductility in y-direction; **d** storey–displacement in y-direction. Blue–achieved ductility per storeys under Durrës 2019 earthquake, red–ductility capacity of the structure per storeys, green–displacement per storeys caused by earthquake excitation, yellow–displacement capacity of the structure presented per storeys

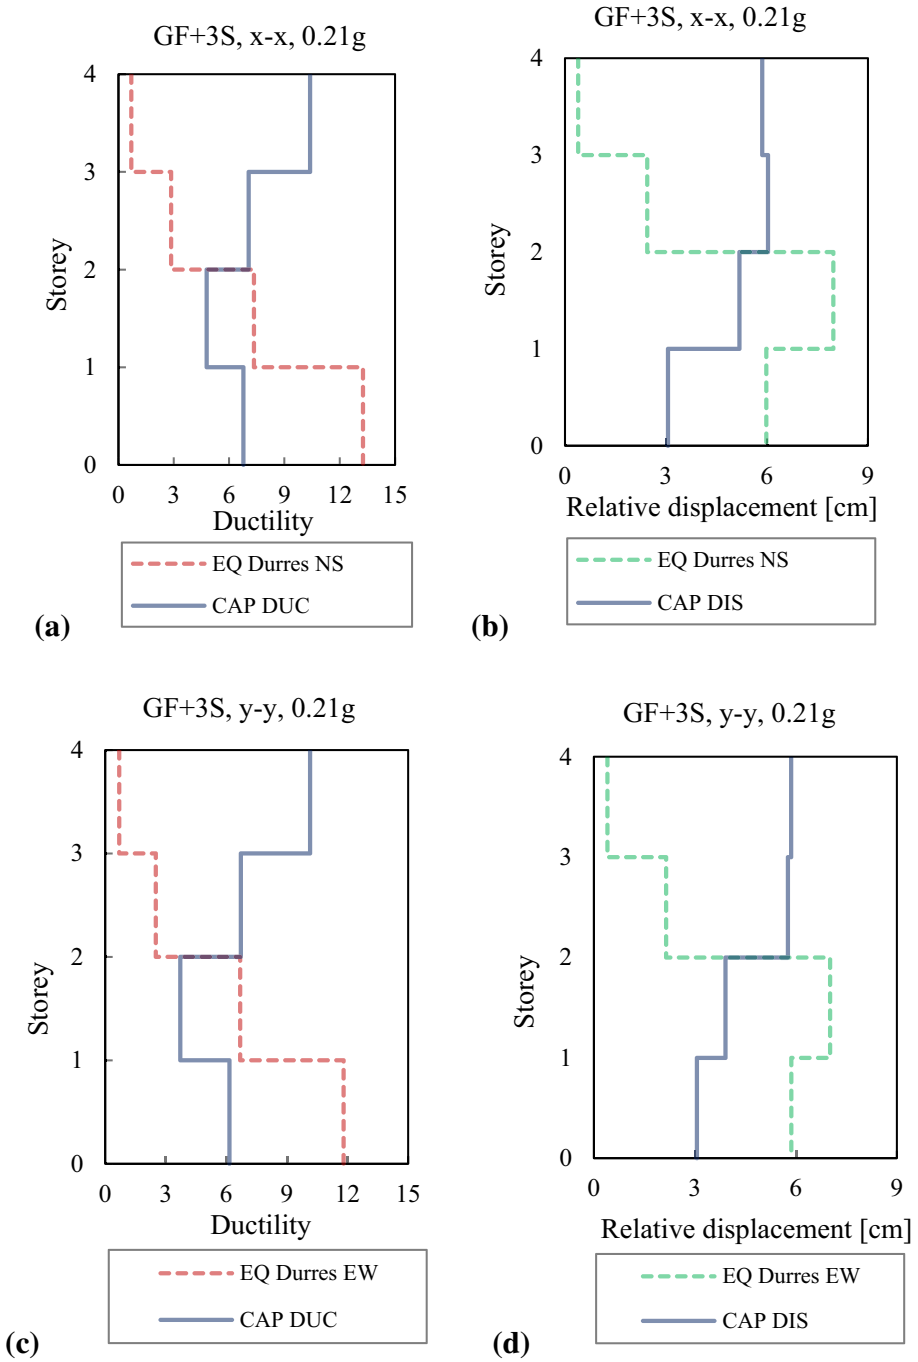
3.3.1.2 Low-rise regular frame structure with shear-walls Unlike frame structures with a height regularity, in this type of structures, the displacement and ductility capacity were exceeded in both x and y direction, the difference in respect to purely frame structures being that the exceedance was approximately twice. Uniform exceedance at both the ground floor and the first storey was observed particularly in respect to displacements, which was not the case with the regular structures without shear walls. Due to the presence of shear walls, the great difference in displacement capacity was reduced. Such performance of this type of structures may cause damage to nonstructural elements and possible slight damage to structural elements by which the stability of the entire structural system is not endangered.

Fig. 13 Graphical presentation of the results for LRR-FR-SW. **a** Storey–ductility in x direction; **b** storey–displacement in x-direction; **c** storey–ductility in y-direction; **d** storey–displacement in y-direction

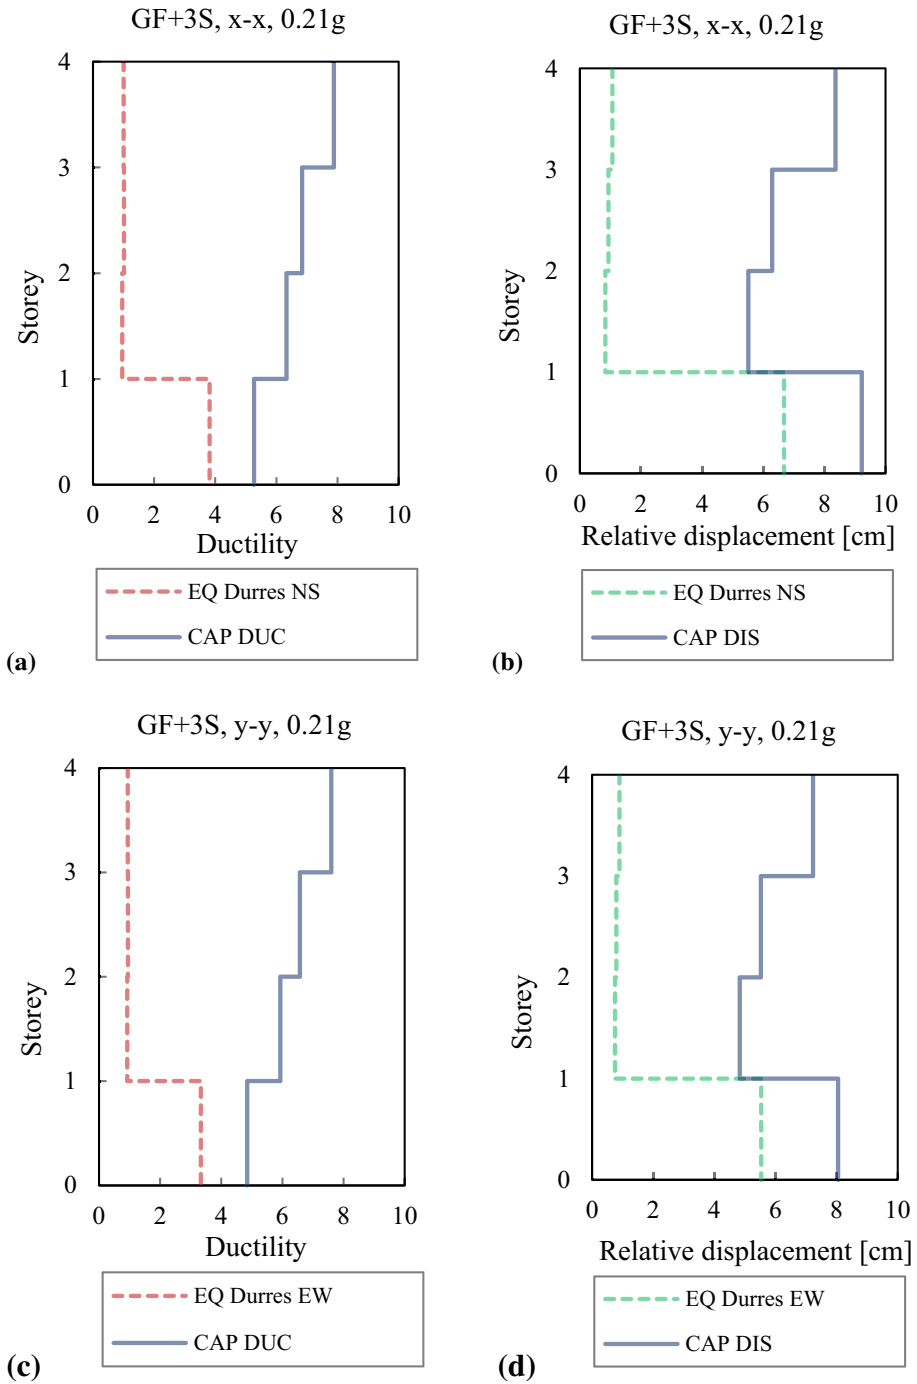
3.3.1.3 Low-rise irregular frame structure In the case of this type of structures, the earthquake that occurred in Durres caused displacements that were smaller than the capacity of the structure (Fig. 14) whereat the earthquake did not cause exceedance of the ductility of the structure. Therefore, neither nonstructural nor structural damage was observed in this type of structures. Under the effect of the occurred earthquake, these structures remain in the linear range of behaviour and generally exhibit the most favourable behaviour. Such behaviour is due to the specific characteristics of the structures of this type, enabling their favourable behaviour during an earthquake with the characteristics of the considered earthquake.

Fig. 14 Graphical presentation of the results for LRI-FS. **a** Storey–ductility in x direction; **b** storey–displacement in x-direction; **c** storey–ductility in y-direction; **d** storey–displacement in y-direction

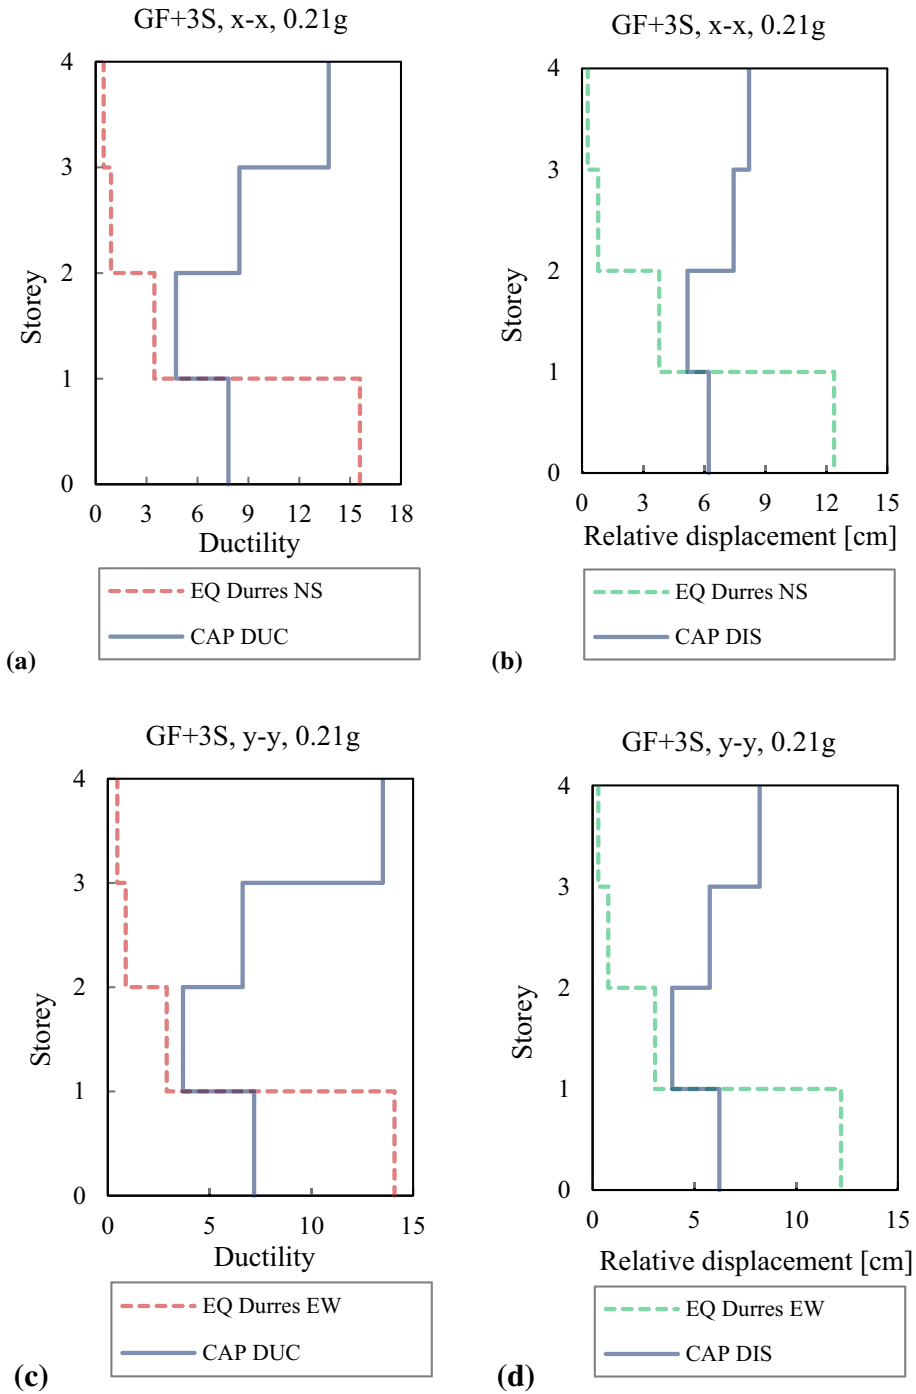
3.3.1.4 Low-rise irregular frame structure with shear walls This type of irregular structures show an extraordinary exceedance of displacements and capacity at the first storey in both directions (Fig. 15). At the second storey, the capacity of both displacement and ductility is almost identical with the displacements and ductility caused by the occurred earthquake. In this type of structural system, nonstructural damage is observed particularly at the first level.

Fig. 15 Graphical presentation of the results for LRI-FS-SW. **a** Storey–ductility in x direction; **b** storey–displacement in x-direction; **c** storey–ductility in y-direction; **d** storey–displacement in y-direction

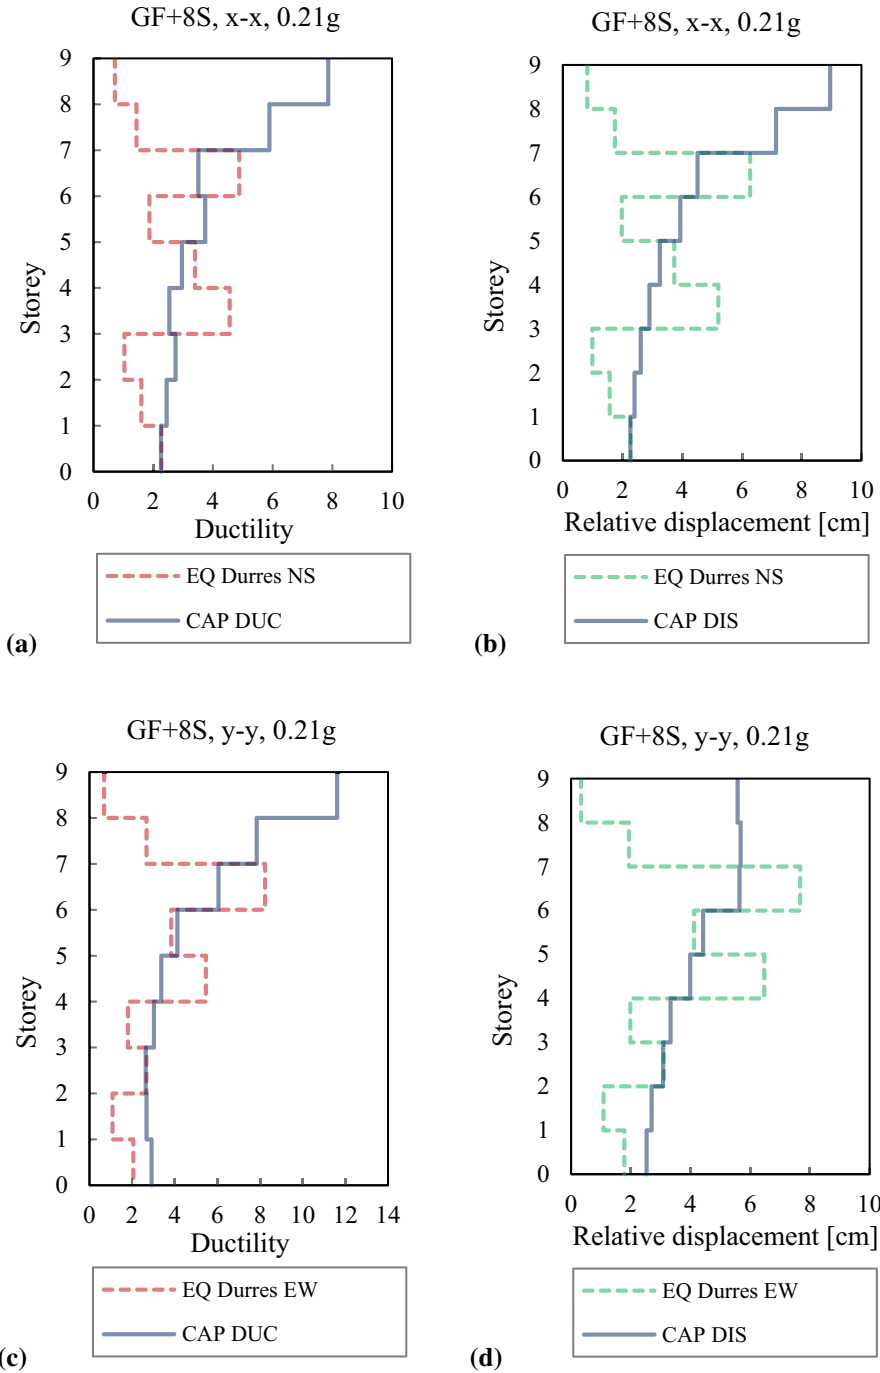
3.3.2.1 Mid-rise regular frame structure From the performed analyses of mid-rise regular structures and the results obtained (Fig. 18), it can be concluded that the displacement and ductility capacity is not exceeded up to the 4th level, up to which the displacement and ductility capacities have an approximate value. The greatest exceedance takes place at the topmost storeys.

Fig. 18 Graphical presentation of the results for MRR-FS. **a** Storey–ductility in x direction; **b** storey–displacement in x-direction; **c** storey–ductility in y-direction; **d** storey–displacement in y-direction

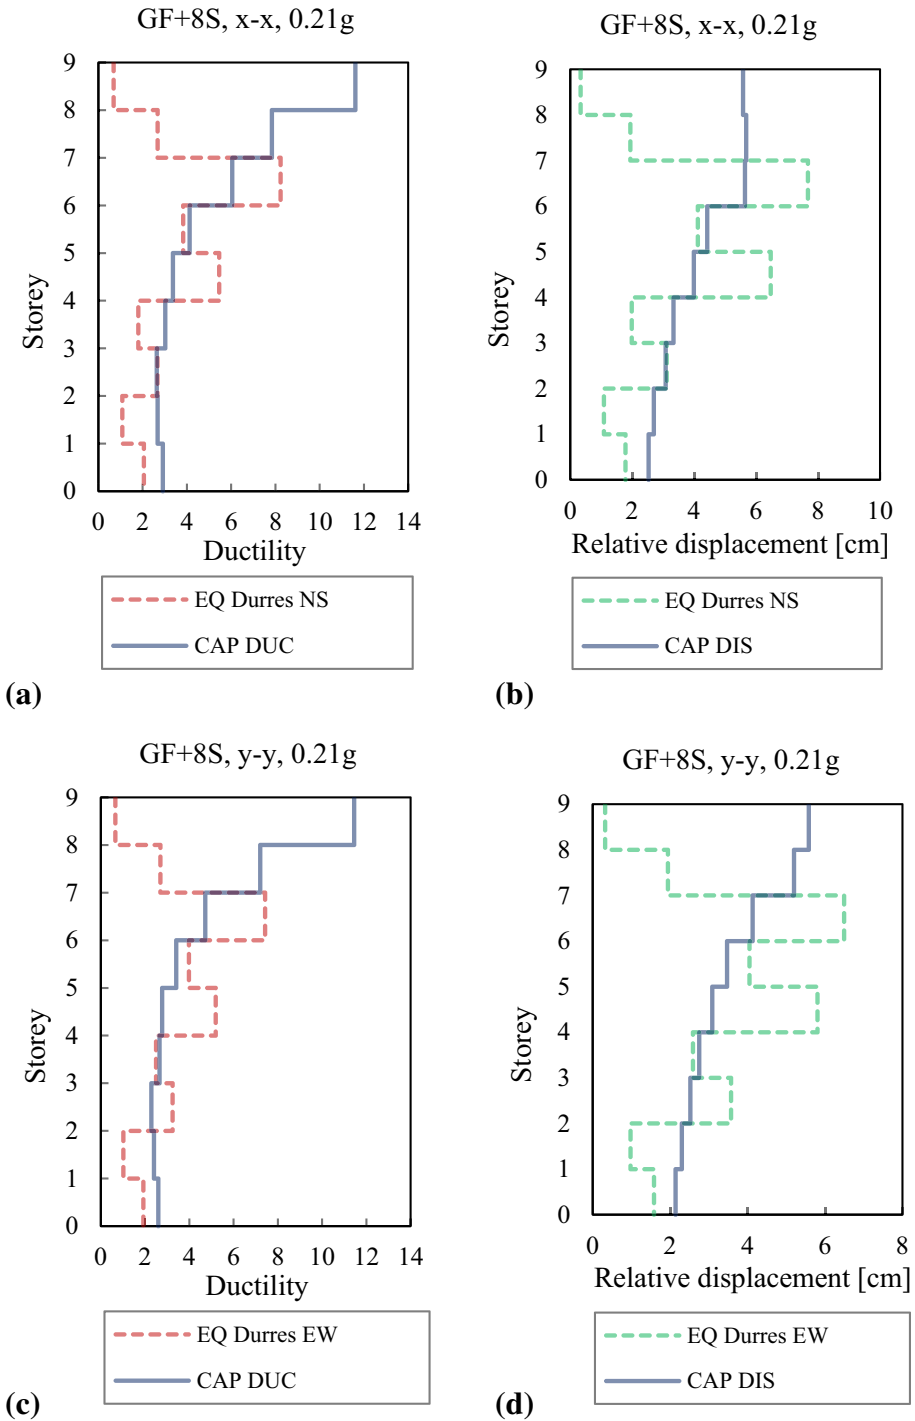
3.3.2.2 Mid-rise regular frame structure with shear walls The results from the analyses of mid-rise regular frame structures with shear walls presented in Fig. 19 show that exceedance of the ductility and displacement capacity starts from the third level and it is exceeded up to the seventh level. At both topmost storeys, there is no exceedance of bearing and displacement capacity.

Fig. 19 Graphical presentation of the results for MRR-FS-SW. **a** Storey–ductility in x direction; **b** storey–displacement in x-direction; **c** storey–ductility in y-direction; **d** storey–displacement in y-direction

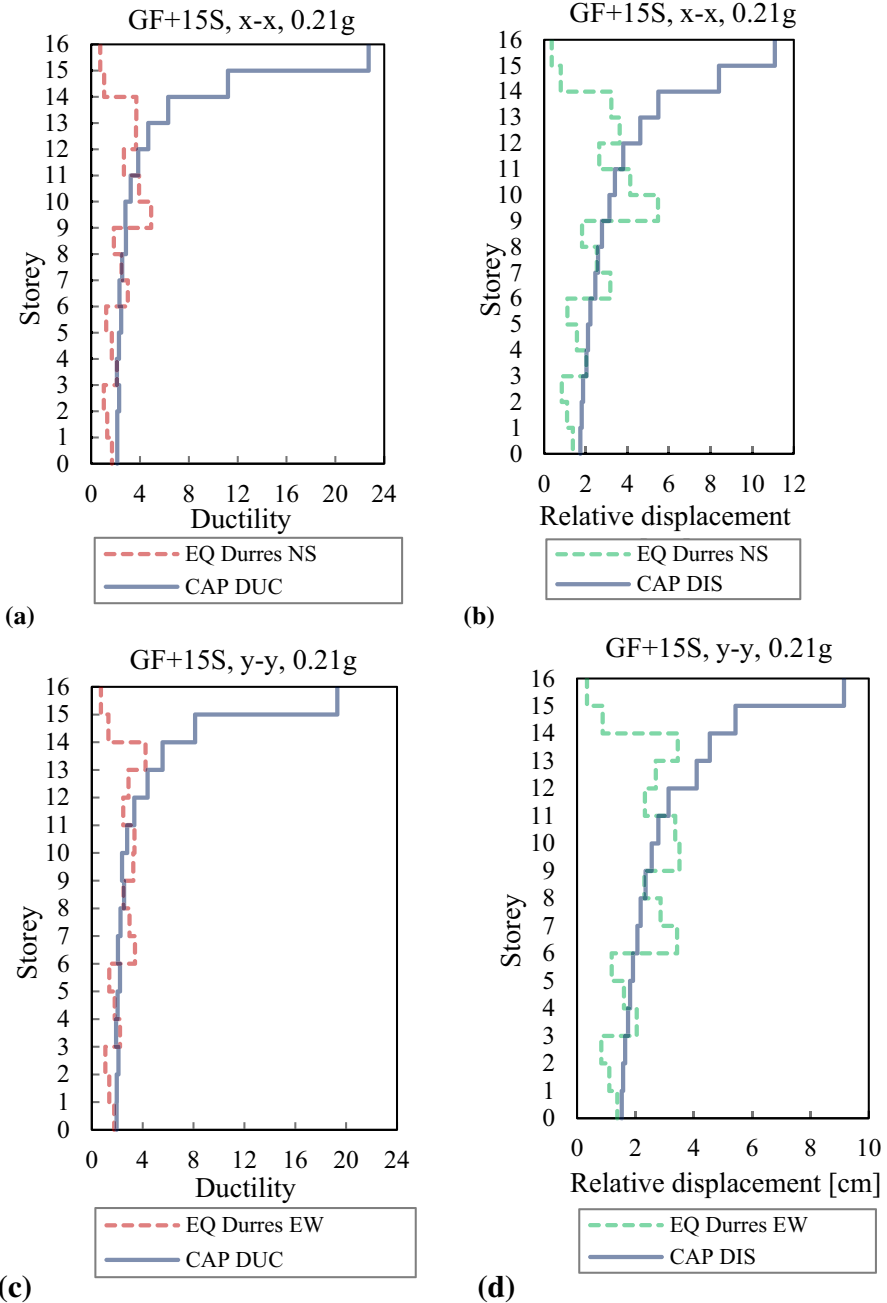
3.3.3.1 High-rise regular frame structure with shear walls This group of structures was analyzed for the purposes of this paper although such type of structures were not observed in the region struck by the earthquake in Durres in 2019. According to the results obtained from the performed analyses, it can be concluded that the behaviour of these structures is not much different than that of the mid-rise buildings (Fig. 21) Similarly to these structures, greater deviations in displacements and ductility take place in the middle storeys, while the displacements and the ductility of the topmost storeys are below the capacity of the structure.

Fig. 21 Graphical presentation of the results for the 16 storey structure with height regularity and frame-shear wall structural system: **a** storey-ductility in X-X direction; **b** storey-displacement in X-X direction; **c** storey-ductility in Y-Y direction; **d** storey-displacement in Y-Y direction
