Reconnaissance analysis on buildings damaged during Durres earthquake Mw6.4, 26 November 2019, Albania: effects to non-structural elements

V. Sheshov¹ · R. Apostolska¹ · Z. Bozinovski¹ · M. Vitanova¹

Keywords Durres earthquake · Rapid visual assessment · Structural damage · Repair and strengthening

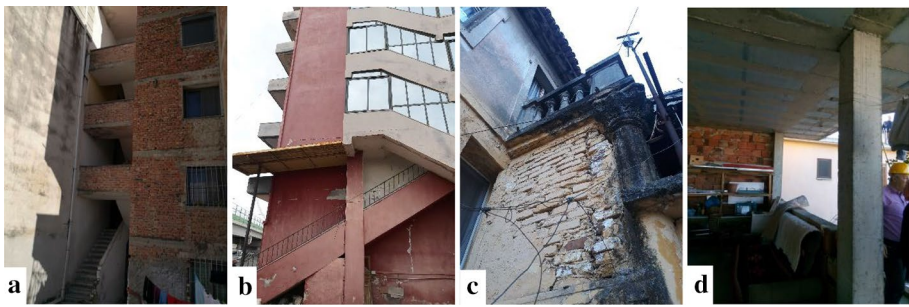
According to structural system, the most numerous 41% structures have combined system (masonry + RC, local nonstandard practice) (Fig. 10 a), then follow reinforced concrete structures (Fig. 10b) (28%), masonry structures (Fig. 10c) are 16%, reinforced concrete flat slab structures (Fig. 10d) are 12% and irregular structures (3% of the total number of inspected structures) (Fig. 11).

Fig. 10 Different structural systems in Durres and Shijak region

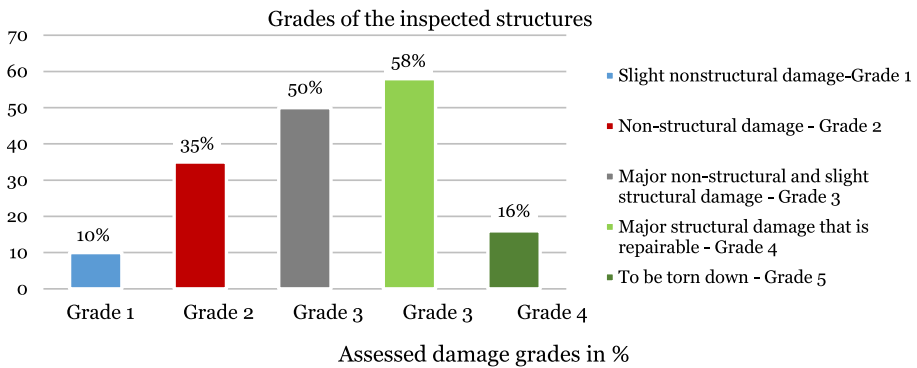
According to the damage grades (Table 5), it can be concluded that from the total number of structures, 10% of the inspected structures are characterized by slight nonstructural damage (grade 1), 35% of the inspected structures have moderate damage to nonstructural elements (grade 2), 50% of the inspected structures suffered major nonstructural damage and slight structural damage (grade 3) while 58% of the structures suffered major repairable structural damage (grade 4). Almost 16% of the total number of inspected structures suffered major structural damage (grade 5) and are anticipated to be demolished (Fig. 13).

Fig. 13 Assessed damage grades in %

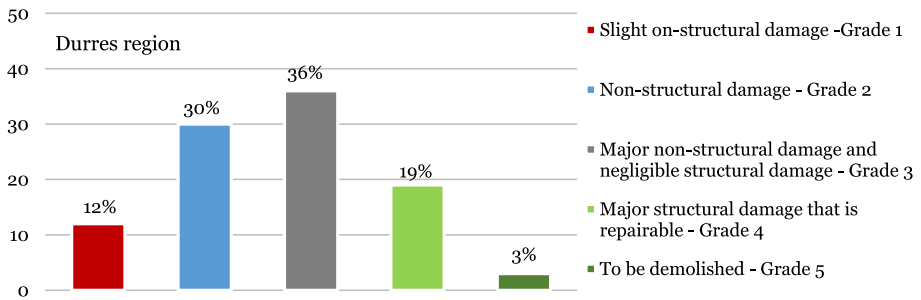
Fig. 27 Review of grades assigned to damaged structures in Durres region (Sesov 2019)

suffered major structural damage that was mainly concentrated in the columns and 3% of the total number of inspected structures were assigned grade 5, meaning that they have to be torn down (Fig. 27).

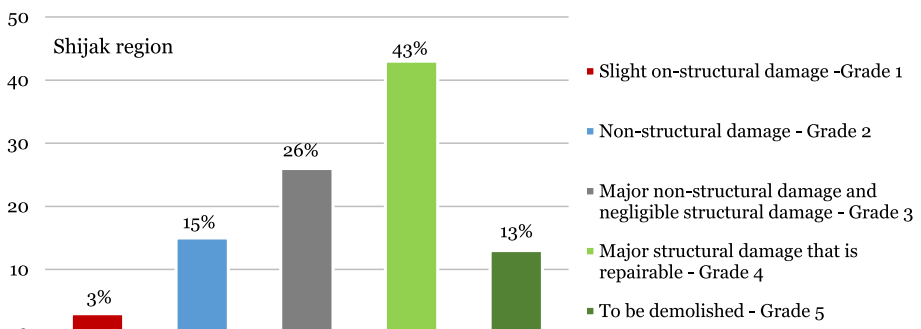
On the territory of Shijak, 3% of the inspected structures are characterized by slight nonstructural damage (grade 1). 15% of the inspected structures have moderate damage to nonstructural elements (grade 2). 26% of the inspected structures suffered major nonstructural damage and slight structural damage (grade 3) while 43% of the structures suffered major repairable structural damage (grade 4). Almost 13% of the total number of inspected structures suffered major structural damage (grade 5) and are anticipated to be torn down (Fig. 28).

Fig. 28 Review of grades assigned to damaged structures in Shijak region (Sesov 2019)
