Experiences from the application of remedial measures in hydrotechnical tunnel on Saska River – M. Kamenica

ZAFIROVSKI Zlatko¹, JOVANOVSKI Milorad², SUSINOV Bojan³, ABAZI Sead⁴, GACEVSKI Vasko⁵

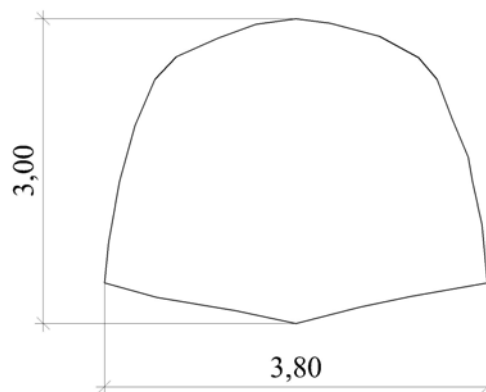
Figure 1. Typical tunnel cross section

The length of the tunnel is 1925 m with longitudinal slope of 5-7 %. Part of the tunnel is under the mine tailings. The cross section varies in width (~3 m) and height (~3 m) depending of the geological composition and tunnel support lining, see Figure 1.
