Second International Symposium on Risk Analysis and Safety of Complex Structures and Components (IRAS 2023)

Solutions and Procedures for Repairing a Damaged Vertical Cylindrical Tank – Depositor

Elisaveta Doncheva^a, Viktor Gochev^b, Aleksandra Krstevska^{a,*}

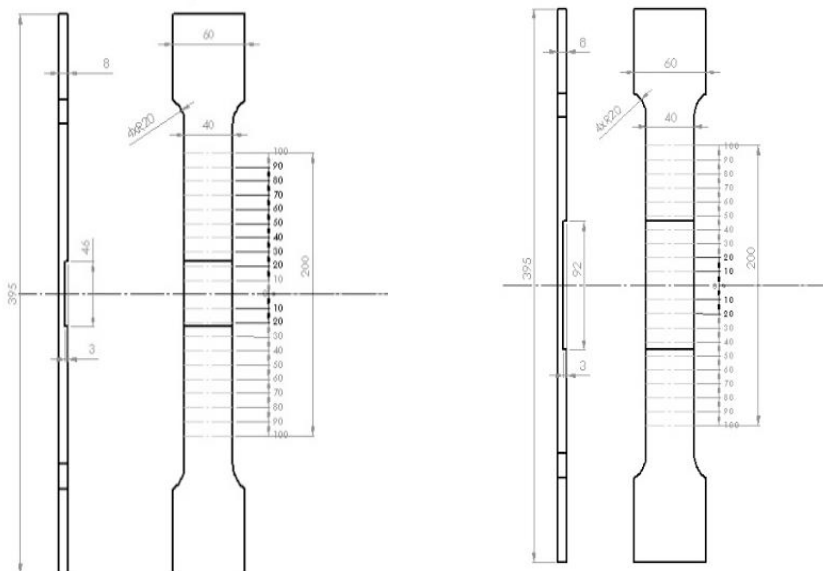
Fig.4: Sketch of the test samples that should be made for the experimental test

Samples were made according to the ISO 6892-1 tensile test standard, with damages similar to those found on the tank, to get a more realistic picture of the impact of the weld and liquid metal. To perceive the difference in the influence of the size of the damage on the strength characteristics, two types of samples were made, as shown in Fig. 4, one with damage length of 46 mm and depth of 3mm and the other with a damage length of 92 mm and depth of 3mm. The samples have a thickness of $t=8$ mm. Table 2 shows the nomenclature of all test specimens classified according to the repair method.
