Monitoring of an earth-rockfill dam and proposing revitalization measures based on interpretation of monitoring data

Bojan SUSINOV¹, Jovan PAPIC¹, Igor PESHEVSKI¹

¹Ss. Cyril and Methodius University in Skopje, Faculty of Civil Engineering Skopje, Republic of North Macedonia
Corresponding author: Bojan Susinov (susinov@gf.ukim.edu.mk)

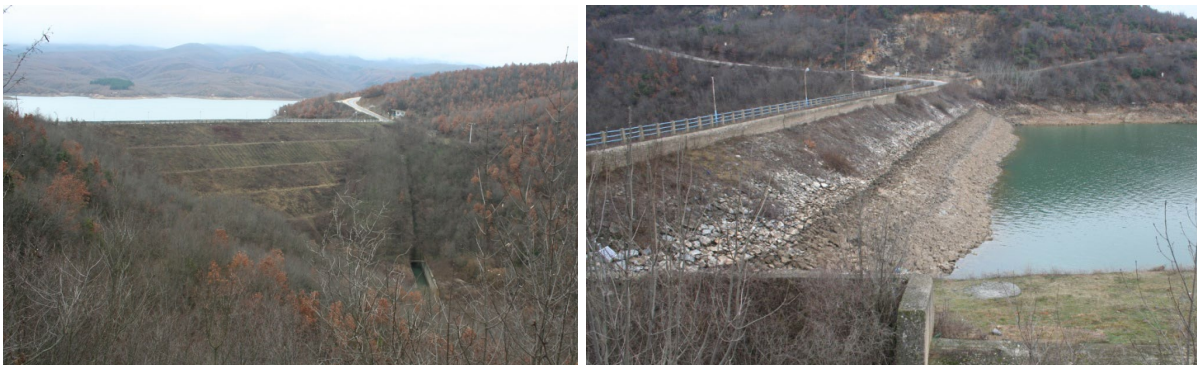
Figure 1: Downstream and upstream slope of the dam.

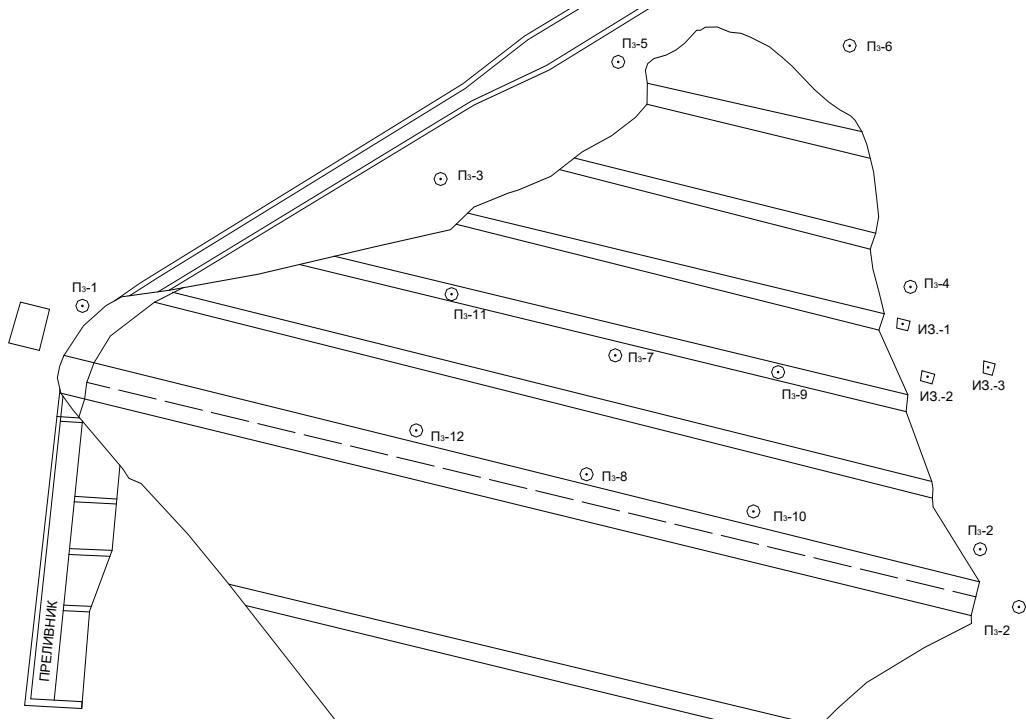
The changes in the groundwater level are monitored with 13 piezometers at intervals provided by the annual Monitoring Program. The layout of the piezometers is given in Figure 3.

Figure 3: Piezometers and sources layout.
