RESTORATION OF THE ELEMENTARY SCHOOL "JOHANN HEINRICH PESTALOZZI"-SKOPJE

Dimitar Papasterevski¹

Aleksandar Radevski

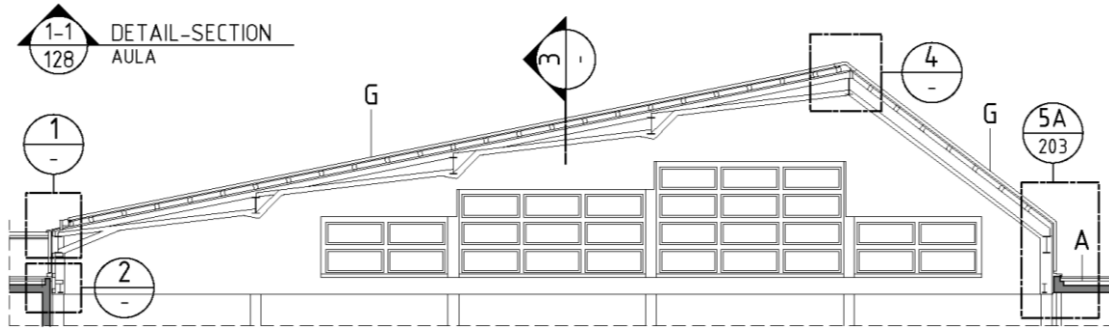
Figure 4: Detail-Section of Aula M=1:200

Furthermore, the implementation of cross-references to indicate architectural details through various graphic representations allows for easy tracking and "reading" of the design. The explicated methodology has been entirely implemented in the elaboration of the design documents for the school reconstruction (Figure 4).

In connection with the constant poor condition of the roofing and waterproofing, a complete set of new architectural details has been developed for all the critical positions. A comprehensive reconstruction has been proposed for the flat non-trafficable roof terraces, which implies the process of extracting all layers up to the finishing floor structures or subfloors. The process of reconstruction further implies cleaning and remediation of all horizontal and vertical gutters, restoration of perimeter sheet flashing, restoration and remediation of dilatations, and protection of the vertical soil pipes from the toilets appearing on the flat non-trafficable roof terraces. The reconstruction covers the roof pitch of the Aula and the gym with complete replacement of the roofing material after the examination of the existing subfloors and particularly the thermal insulation (Figure 5).

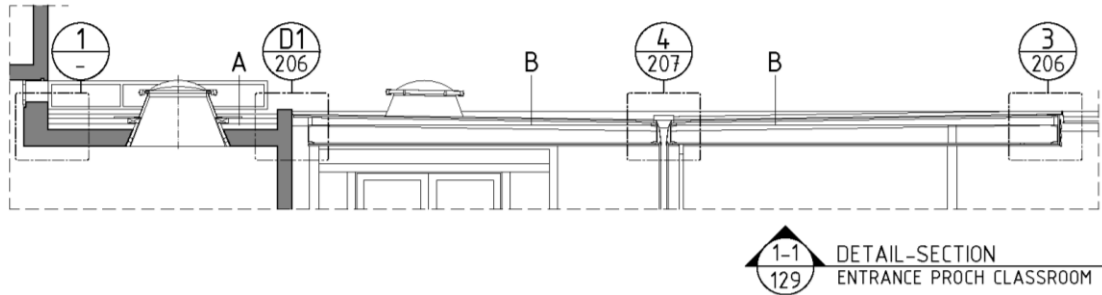
Figure 6: Detail-Section entrance porch classroom, M=1:100

The subsequent part tackles the detailed section of the entrance porch (Figure 6) and the classroom segment at the level of architectural detail (Figure 7).
