CHIMNEYS' INFLUENCE ON FIRE RISK OF SOLID WOOD STRUCTURES IN RESIDENTIAL BUILDINGS IN RURAL BALKAN SETTLEMENTS

Original scientific paper
<https://doi.org/10.2298/TSCI190525138L>

According to official fire statistics, chimney fires account for almost 20% of all fires that occur in family residential buildings every year in the Balkan region. The high temperature from the chimneys may have an influence on fire spreading to the wooden girders. The objective of the study was to gather and analyse data on timber structure fire incidents occurring in family residential buildings in lowland rural settlements in Serbia (2010-2014) and a mountain settlement in Montenegro (2007-2013) in order to determine the extent to which existing data can be used in fire risk assessment. Additionally, the chimney-timber floor heat transfer mechanism was investigated, namely, the time dependent temperature distribution in the cross-section of few types of mostly used chimneys and floor structures were analysed. This research illustrates how the lack of chimney maintenance and social vulnerability of the settlements (aged rural population with low incomes, living in many cases alone in old houses in area

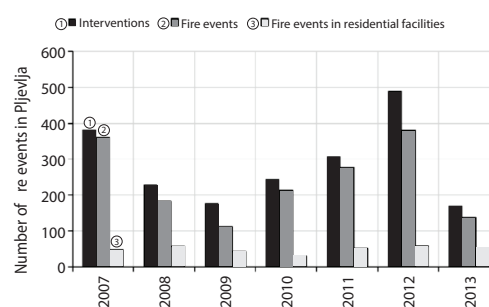
Figure 3. Number of all fire events and interventions, in the period 2007-2013

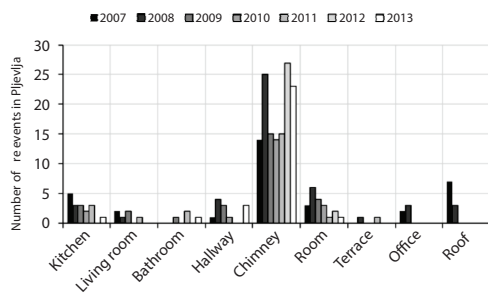
Figure 5. Fire events distribution in Pljevlja municipality, according to place of origin

paid to chimney inspection and maintenance. There are approximately 15-30 chimney fires per year in Pljevlja, making them the most frequent place of fire occurrence in housing facilities. The share of roof fires in the total number of residential building fires is 5%. According to the fire-brigades' reports, most of the roof fires started near the chimneys. In terms of potential risk, this may indicate the possibility that 7.5% of chimney fires will spread to the wooden roof structures, fig. 5.

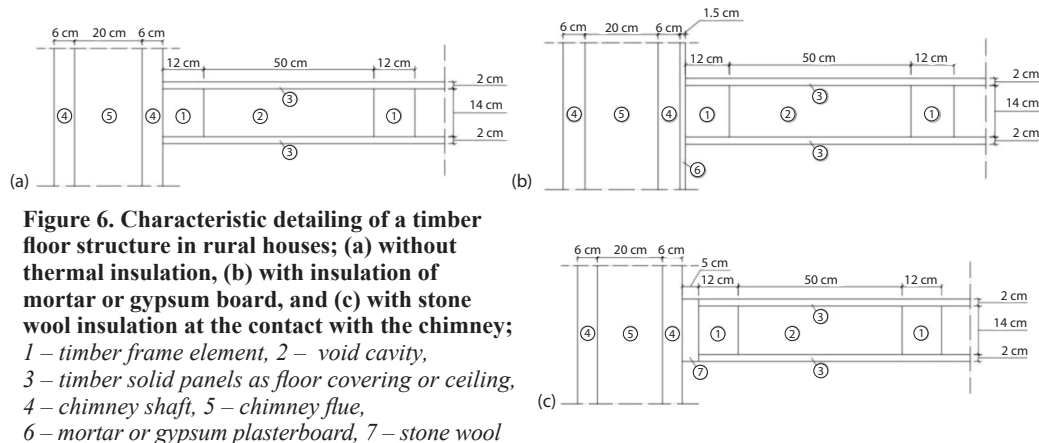
Figure 6. Characteristic detailing of a timber floor structure in rural houses; (a) without thermal insulation, (b) with insulation of mortar or gypsum board, and (c) with stone wool insulation at the contact with the chimney; 1 – timber frame element, 2 – void cavity, 3 – timber solid panels as floor covering or ceiling, 4 – chimney shaft, 5 – chimney flue, 6 – mortar or gypsum plasterboard, 7 – stone wool

heating effects, there is no insulating protective layer along the shaft, or insulation is used only at the contact between the chimney and the wooden elements, fig. 6(c).

- Case I – the timber frame member (beam) is in direct contact with the chimney, fig. 6(a),
- Case II – an insulation of 1.5 cm gypsum plasterboard is placed between the timber frame member (beam element) and the chimney, fig. 6(b),
- Case III – an insulation of 5 cm stone wool is placed between the timber frame member (beam element) and the chimney, fig. 6(c).

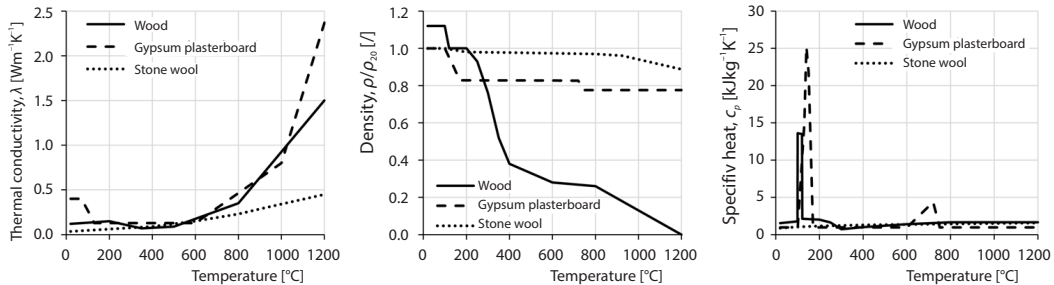
Figure 7. Temperature dependent properties of wood [30], gypsum plasterboard and stone wool [37]

The chimney is built of bricks, $d = 6$ cm. The coefficient of thermal conductivity for the brick is assumed to be constant. The thermal properties of all other constitutive materials (wood, stone wool and gypsum) are temperature dependent, fig. 7, as recommended in [30, 37], and incorporated in the computer program FIRE [28] which is used for the numerical analysis. Material properties at room temperature (20 °C) are given in tab. 3.

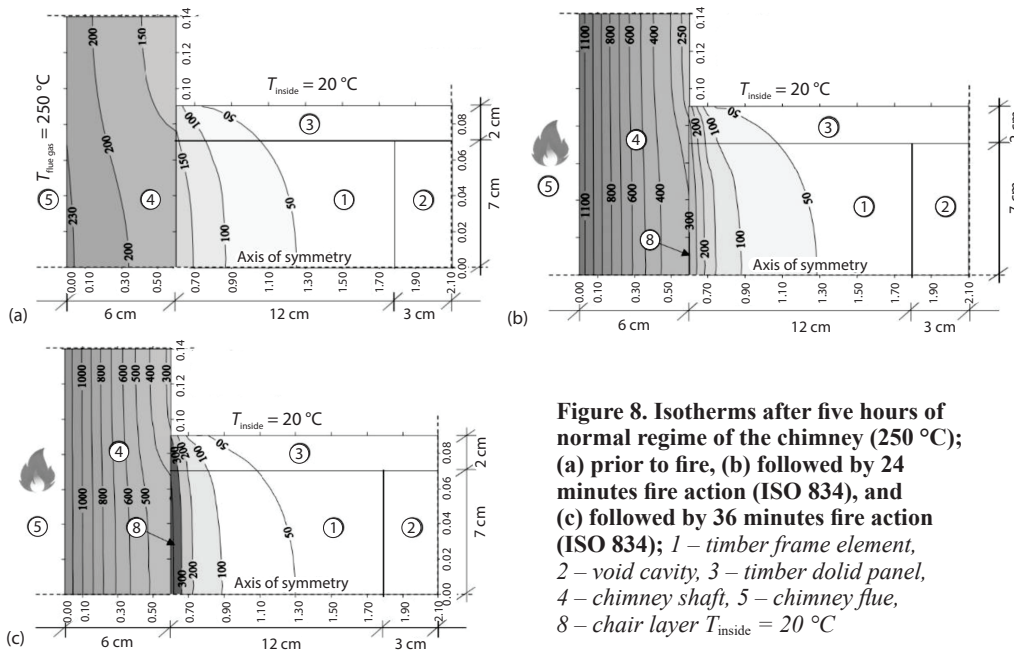
Figure 8. Isotherms after five hours of normal regime of the chimney (250 °C); (a) prior to fire, (b) followed by 24 minutes fire action (ISO 834), and (c) followed by 36 minutes fire action (ISO 834); 1 – timber frame element, 2 – void cavity, 3 – timber solid panel, 4 – chimney shaft, 5 – chimney flue, 8 – chair layer $T_{\text{inside}} = 20$ °C

In case I, the timber frame member (beam element) is in direct contact with the chimney. The isotherms in the timber floor cross-section after five hours of normal regime are presented in fig. 8(a). Within a short time after the start of the chimney fire ($t = 24$ minutes), the temperature in the inner part of the beam cross-section reaches 300 °C, fig. 8(b). At that moment, the charring process starts and after 12 minutes ($t = 36$ minutes), the whole contact sur-

face reaches 300 °C, fig. 8(c). This moment may be assumed as the moment when spontaneous ignition of the wooden elements starts. The charring rate in this case is 0.83 mm/min (after 6 minutes, the char layer is 5 mm).

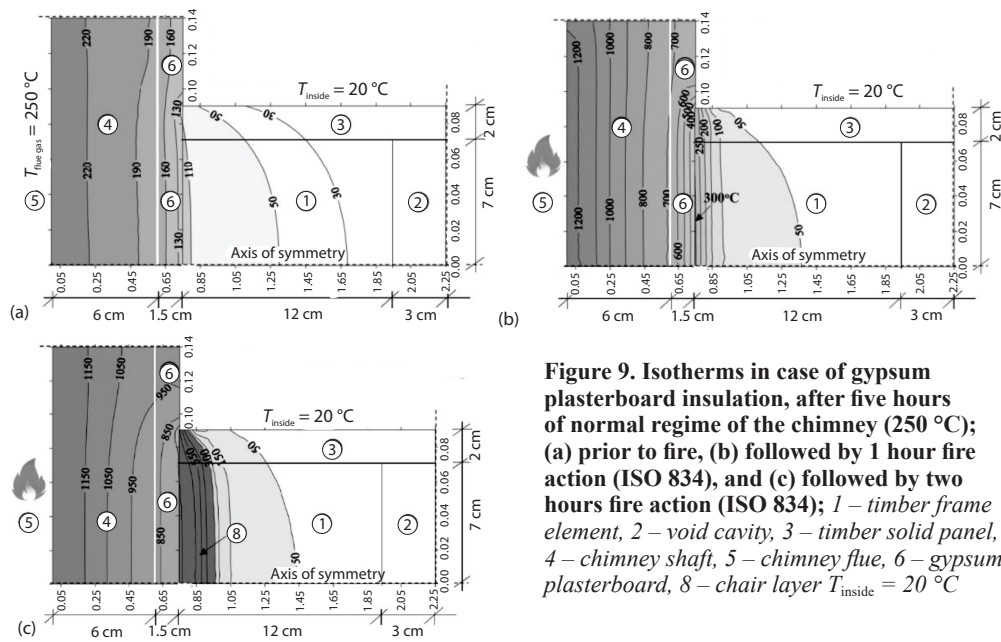
Figure 9. Isotherms in case of gypsum plasterboard insulation, after five hours of normal regime of the chimney (250 °C); (a) prior to fire, (b) followed by 1 hour fire action (ISO 834), and (c) followed by two hours fire action (ISO 834); 1 – timber frame element, 2 – void cavity, 3 – timber solid panel, 4 – chimney shaft, 5 – chimney flue, 6 – gypsum plasterboard, 8 – char layer $T_{\text{inside}} = 20\text{ °C}$

In Case II, an insulation of 1.5 cm gypsum plasterboard is placed between the timber frame member (beam element) and the chimney, fig. 6(b). In this case, the moment of spontaneous ignition is postponed. The isotherms in the timber floor cross-section after five hours of normal regime are presented in fig. 9(a). After one hour of fire action, the temperature at the timber beam surface reaches 300 °C, fig. 9(b). After two hours, fig. 9(c), as a result of the insulating layer, the char layer thickness is only 25 mm, resulting in the charring rate of 0.416 mm per minute.

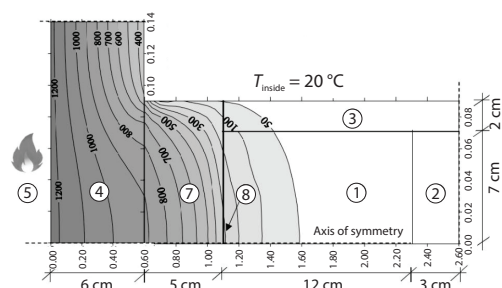
Figure 10. Isotherms in case of a 5 cm stone wool insulation between the chimney and the wooden beam element, after five hours of normal regime of the chimney, followed by 2.3 hours fire action (ISO 834); 1 – timber frame element, 2 – void cavity, 3 – timber solid panel, 4 – chimney shaft, 5 – chimney flue, 7 – stone wool, 8 – chair layer $T_{\text{inside}} = 20\text{ }^{\circ}\text{C}$

In case III, an insulation of 5 cm stone wool is placed between the timber frame member (beam element) and the chimney, fig. 6(c). In this case, the moment of spontaneous ignition is much more postponed. After 2.3 hours of fire action, the temperature reaches 300 °C, fig. 10 at some points of the cross-section. Normally, chimney fires do not last so long [38].
